## **Appendices (Provided on CD)**

Appendix D: Self-Evaluation Reports

## City of College Station ADA Self-Evaluation and Transition Plan

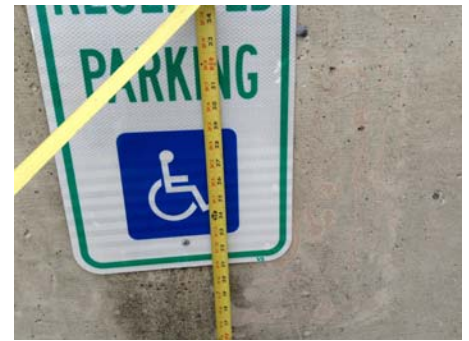
Parking Violation 1 - Level 4 - The four accessible parking signs are 23" above the parking surface to the symbol of accessibility. A mounting height of 60" minimum is required.

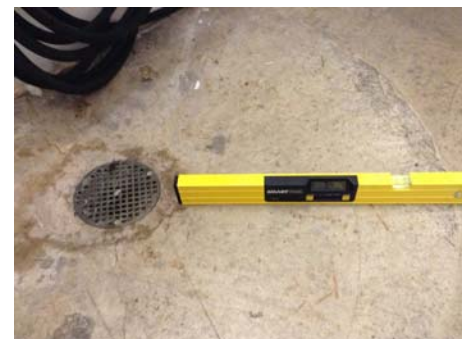
RR Violation 3 - Restrooms - The slope to the floor drains in the restrooms is approximately 7.6%.

**Recommendation:** The drains must be modified to achieve a 1:48 (2%) maximum slope.

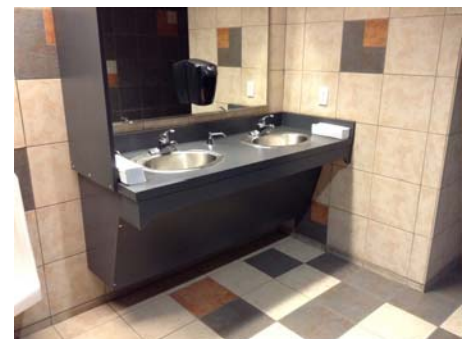
RR Violation 2 - 1st floor Lobby Men Restroom - The soap dispenser located above the lavatory counter is 50" above the floor. Accessible reach range over an obstruction is 44" maximum.

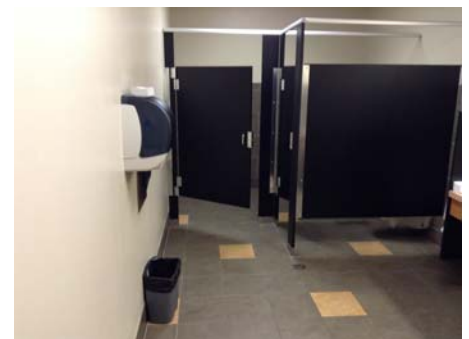
RR Violation 13,14 - Men Restroom 240 - The door into the accessible toilet compartment swings outward and has 6" of maneuvering clearance on the pull side of the door where 18" minimum is required. The door into the accessible toilet compartment does not self-close.

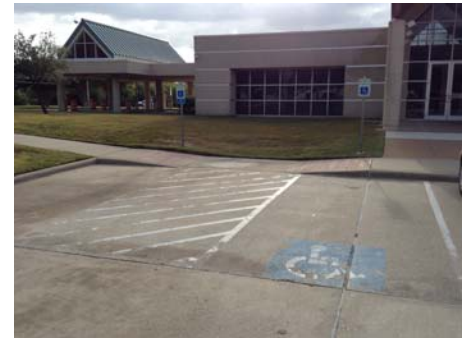
Parking Violation 1 - Customer Parking - The right accessible parking space has a longitudinal slope of 2.6% along the length of the parking space where 1:48 maximum is required.

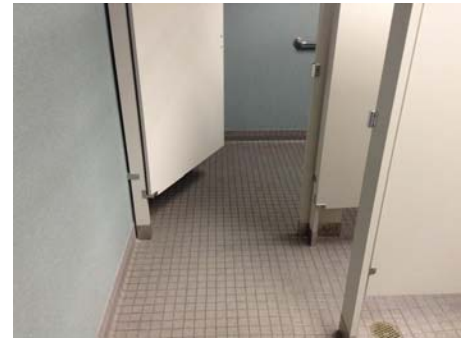
RR Violation 3 - Employee Men Restroom - Door to accessible toilet compartment does not self-close.

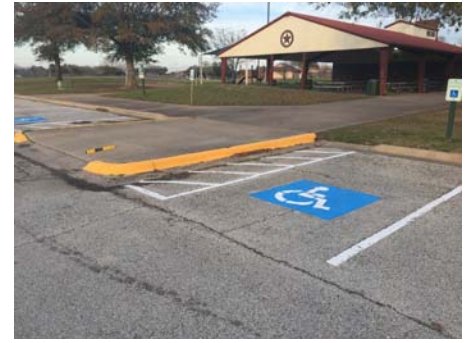
Parking Violation 1 - Both of the accessible parking spaces serving the pavilion must be restriped to meet the minimum dimensions for accessible parking spaces.

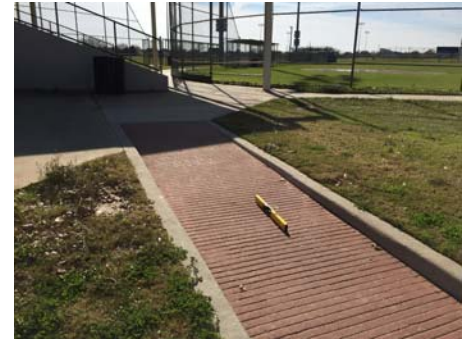
AR Violation 1 - The sloped walk leading up to the west side little league fields has a 7% running slope and is not treated as a ramp.

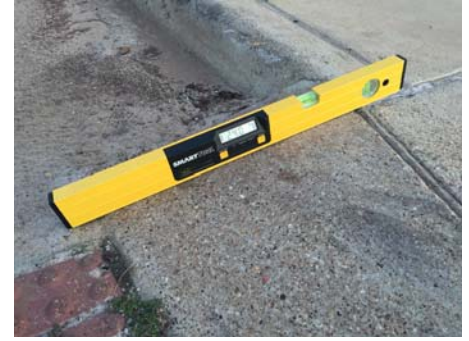
AR Violation 5 - The curb ramp flares exceed 20% slope where 10% maximum is required.

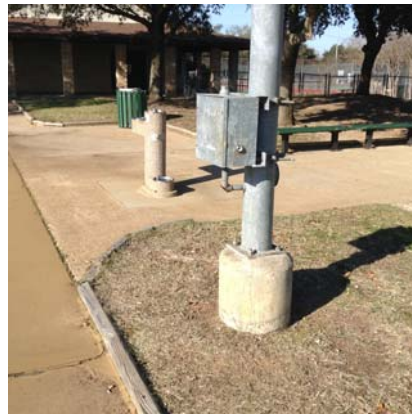
AR Violation 10 - No accessible route is provided to the basketball court light control.

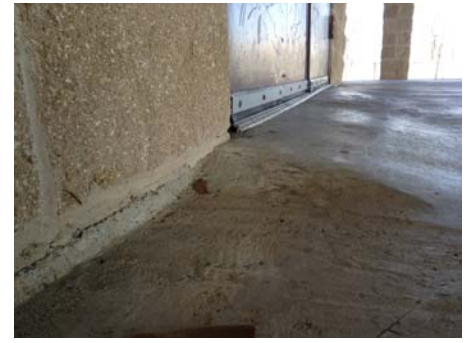
Entrance Violation 1 - The entrance door into the pool house has a 7% slope on the exterior of the door where it is required to be level.

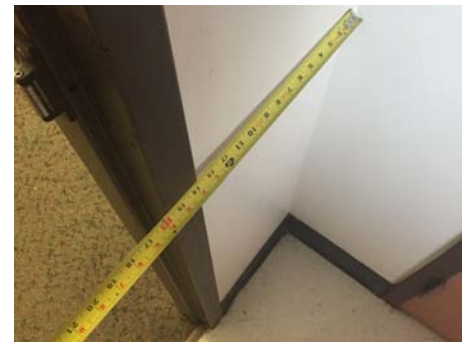
Hallway Violation 2 - Within the Southwood Community Center the doors in the restroom corridor have 16" of clearance on the pull side of the doors.

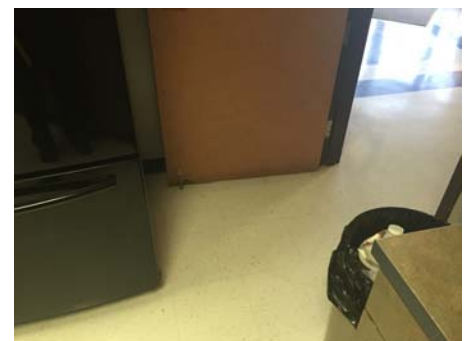
Hallway Violation 5 - The width of the route into the Southwood Community Center staff break room is only 29" between the refrigerator and the countertop.

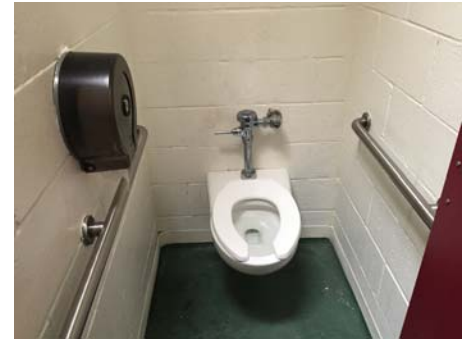
RR Violation 3 - The pool facility locker rooms are not substantially compliant.

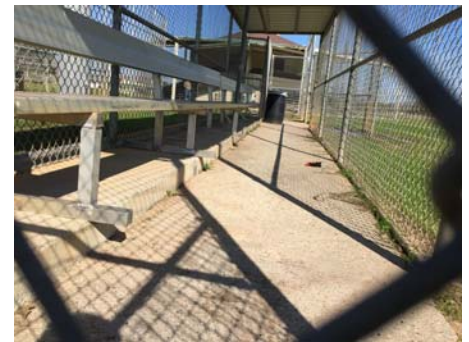
Park Violation 2 - The dugouts do not include at one wheelchair seating space within the player seating. The seating is on a raised concrete platform.

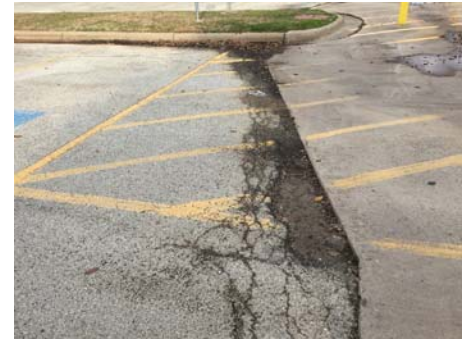
Parking Violation 1 - The asphalt ground surface within the six accessible parking spaces is cracking and deteriorating where it meets the concrete surface, creating level changes greater than 1/4".

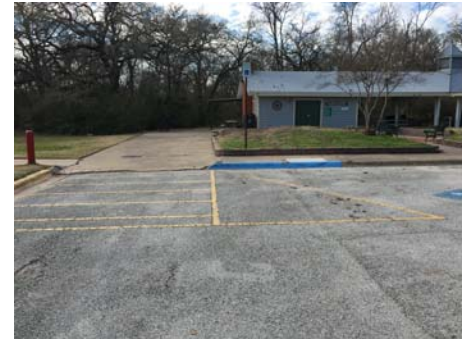
Parking Violation 4 - One additional accessible parking space is required to serve the parking lot at the pavilion and it must also connect to the pavilion and basketball court by an accessible route.

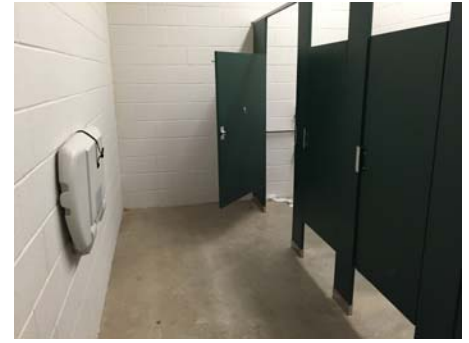
AR Violation 3 - Ball field restrooms - The main path of travel into each restroom has a baby changing station that protrudes into the path of travel to the stalls.

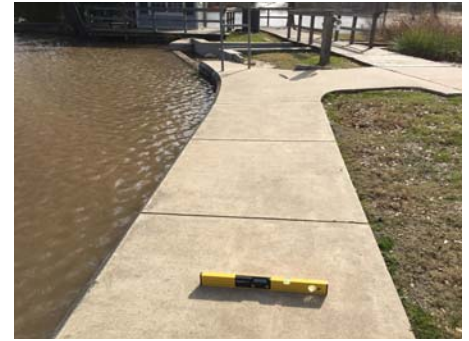
Violation 15 - The cross slope of the sidewalk directly in front of the lake/pond on the west side is up to 3.5%. Again, because there is no edge protection between this path and the water, we see this as a liability issue for someone with limited mobility and should be resolved.

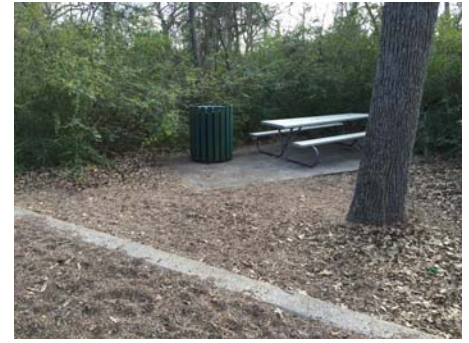
AR Violation 21 - There is no accessible route leading to the picnic table serving the playground.

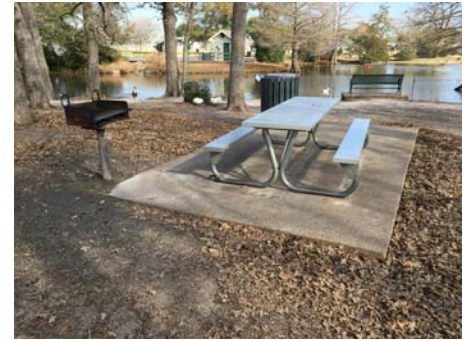
AR Violation 24 - No accessible route is provided to the picnic areas by the water.

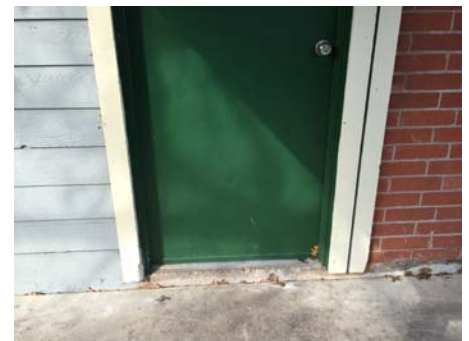
AR Violation 27 - The door into the concession area from the pavilion has a knob and a level change to get inside.

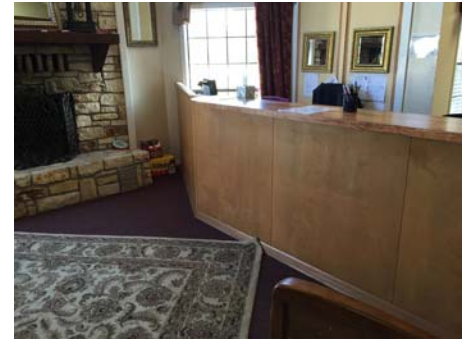
Misc Violation 2 - The main counter in the lobby has a height of 45" high with no lowered section.
