## **Appendices (Provided on CD)**

Appendix D: Self-Evaluation Reports

## City of College Station ADA Self-Evaluation and Transition Plan

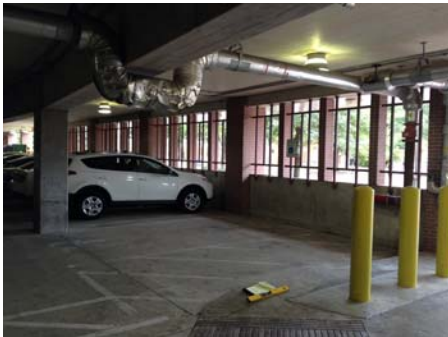
Parking Violation 2 - Level 1 - The vertical clearance at the van accessible parking space is reduced to 84" due to overhead duct.

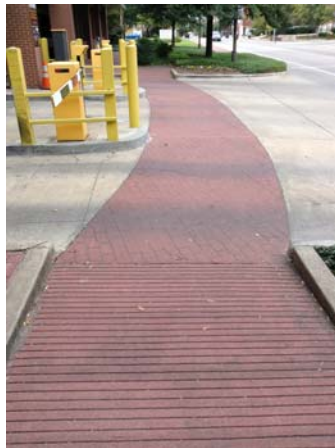
AR Violation 1 - The curb ramp that provide access across the College Main garage entrance has a 3.9% cross slope.

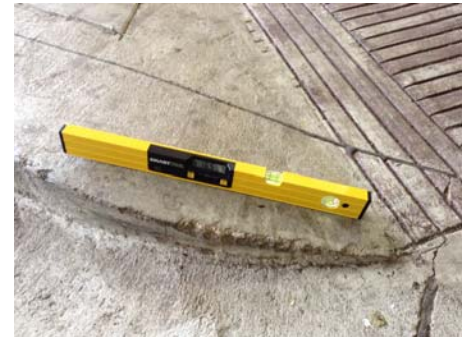
AR Violation 2 - Level 1 - The curb ramps serving the accessible parking have flares with slopes of 16.4% and 21.2% where 1:10 (10%) maximum is required.

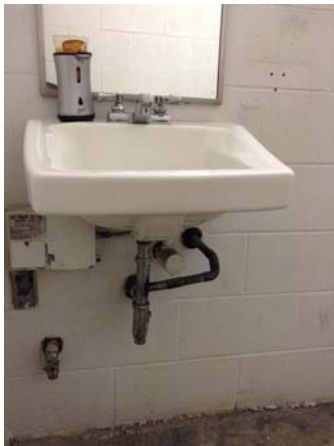
RR Violation 1 - Restrooms - The exposed water lines and drain pipes under one of the lavatories are not protected against contact.

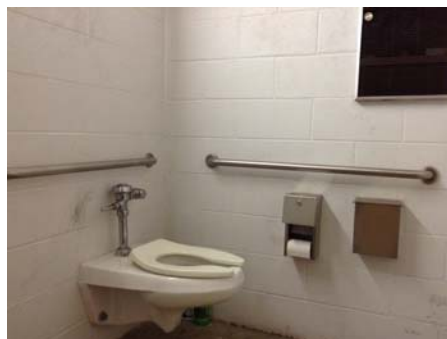
RR Violation 2 - Restrooms - The water closets are 19-3/4" and 20-1/4" to the top of the seat where 17"-19" is required.

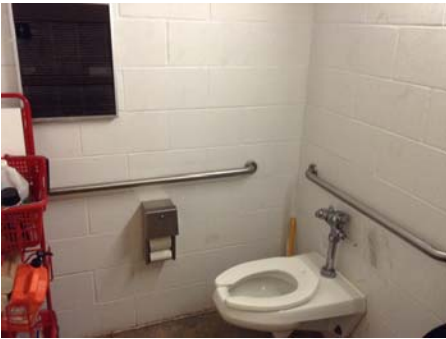
RR Violation 4 - Restrooms - The fan controls are above accessible reach range.

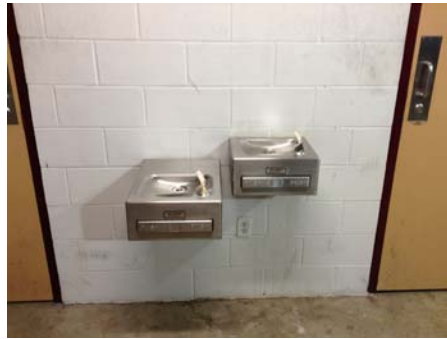
Misc Violation 1 - The high drinking fountain located between the restrooms is a protruding object.

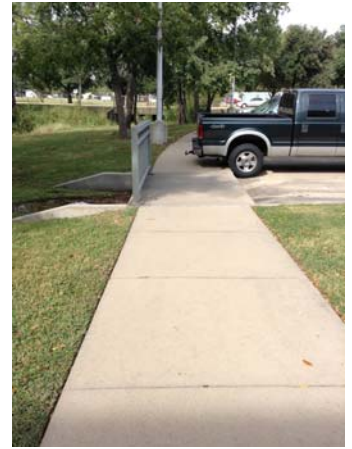
AR Violation 1 - Vehicle overhangs obstruct the clear width of the accessible route to Krenak Tap Rd.

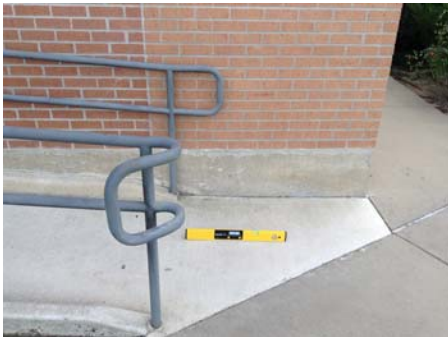
AR Violation 2 - The exterior ramp that provides access up to the north side main entrance has a running slope of 4% and a cross slope of 2.7% within the landing area at the bottom of the ramp. Ramp landings must have a cross slope of 1:48 maximum in all directions.

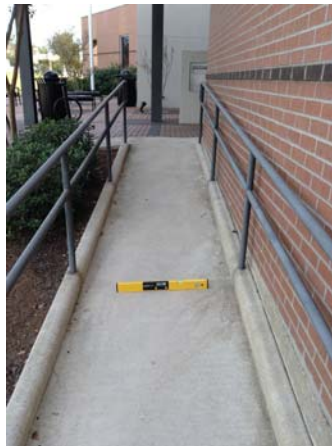
AR Violation 3 - The exterior ramp that provides access up to the north side main entrance has a cross slope of 3.8% within the ramp segment. The ramp must have a cross slope not exceeding 1:48 throughout its length.

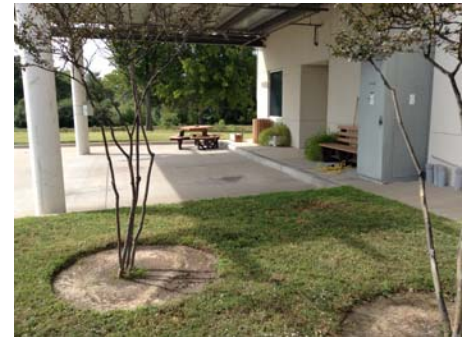
AR Violation 4 - No accessible connecting route is provided to serve the picnic table provided at the covered service entrance on the south side of the building.

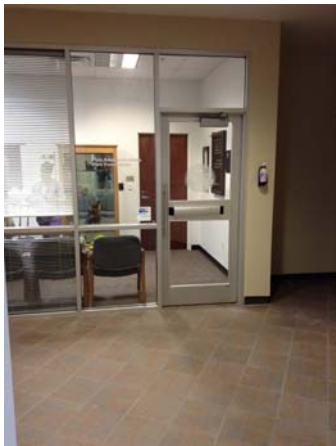
Hallway Violation 1 - The room identification at the the Fire Administration/Fire Prevention office area is etched into the glass adjacent to the the door. Signs designating permanent spaces must be accessible and include raised tactile characters and Braille.

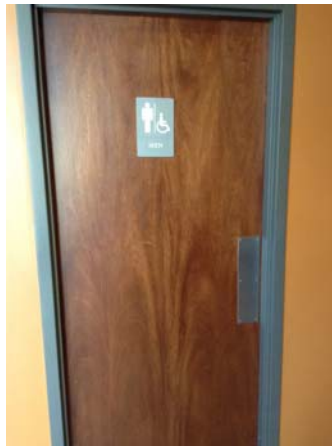
RR Violation 1,5 - 1st floor lobby Men Restroom - The room sign is located on the door where it is required to be installed on the latch side of the door.

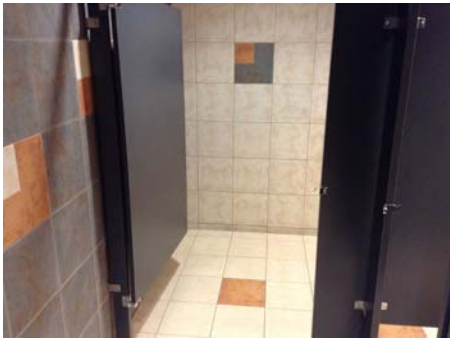
RR Violation 3,4 - 1st floor lobby Men/ Women Restrooms - The door into the accessible toilet compartment does not self-close.

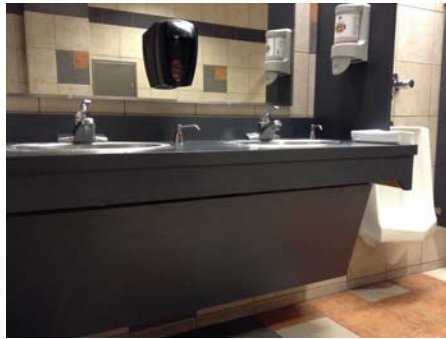
RR Violation 6 - 1st floor Men Restroom (Fire Admin) - The soap dispensers located above the lavatory counter are 49" above the floor. Accessible reach range over an obstruction is 44" maximum.

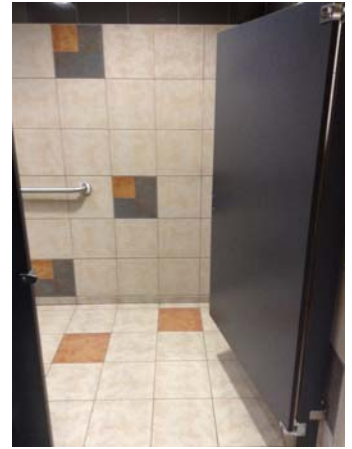
RR Violation 7 - 1st floor Men Restroom (Fire Admin) - The door into the accessible toilet compartment does not self-close.

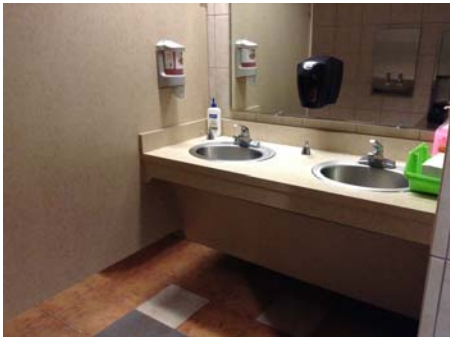
RR Violation 8 - 1st floor Women Restroom (Fire Admin) - The soap dispensers located above the lavatory counter are 49" above the floor. Accessible reach range over an obstruction is 44" maximum.

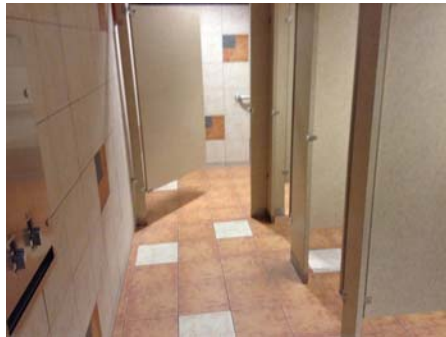
RR Violation 9 - 1st floor Women Restroom (Fire Admin) - The door into the accessible toilet compartment does not self-close.

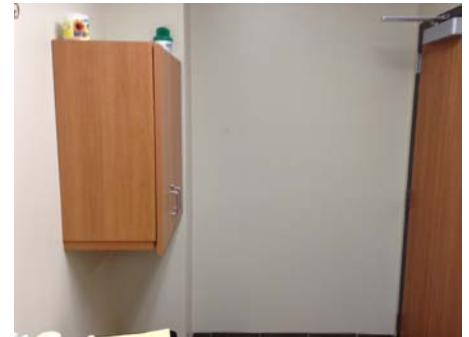
RR Violation 10 - Women Restroom 241 - The wall mounted storage cabinet and the wall mounted paper towel dispenser are protruding objects as they extend up to 15" from the wall into the circulation path within the restroom.

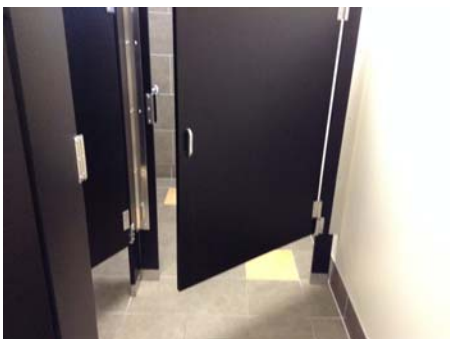
RR Violation 11 - Women Restroom 241 - The door into the accessible toilet compartment swings outward and has 6" of maneuvering clearance on the pull side of the door where 18" minimum is required.

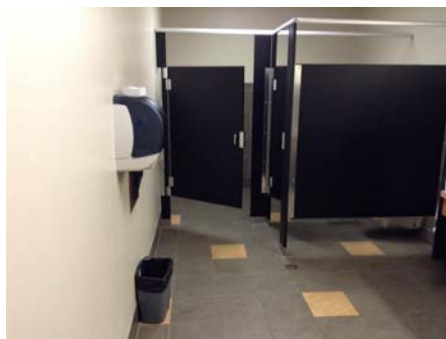
RR Violation 12 - Men Restroom 240 - The paper towel dispenser is a protruding object as it extends approximately 8" from the wall into the circulation path within the restroom.

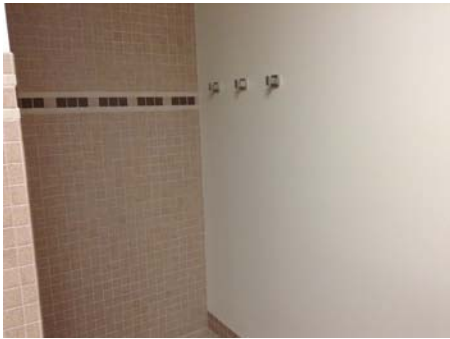
RR Violation 15 - Women Restroom 255  
- The wall mounted hooks next to the shower are installed at 60" above the floor. At least one hook must be provided at 48" high.

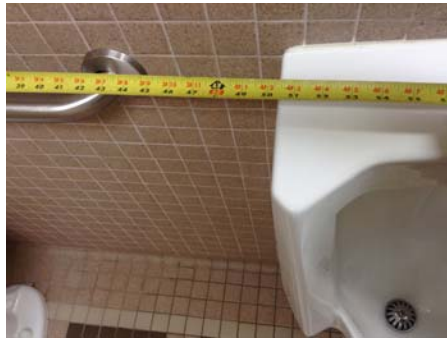
RR Violation 16 - Men Restroom 254 -  
The clearance between the water closet sidewall and the urinal is 50-1/2". The water closet must have a 60" minimum clearance from the sidewall. At the time of construction 2002/2003 the only fixture permitted to be within the 60" minimum clearance was a lavatory.

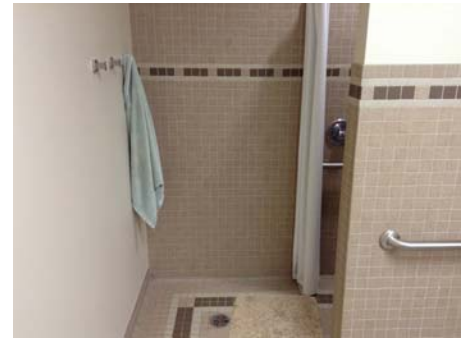
RR Violation 17 - Men Restroom 254 -  
The wall mounted hooks next to the shower are installed at 60" above the floor. At least one hook must be provided at 48" high.

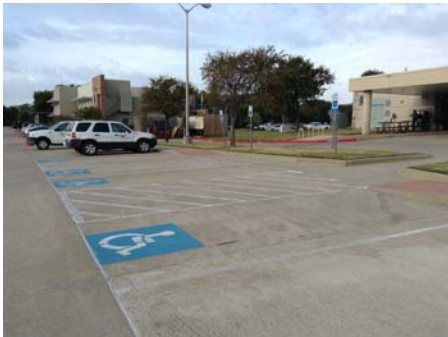
Parking Violation 2 - Employee Parking - The four accessible parking spaces have a longitudinal slope of 2.6% to 3.3% along the length of the parking spaces where 1:48 maximum is required.

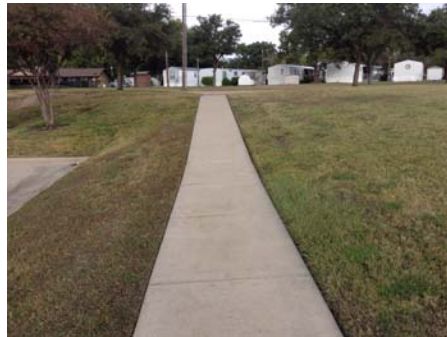
AR Violation 1 - The sidewalk that connects the sidewalk along Krennek Tap Road to the main entrance includes running slopes of 5.8% to 6.6% and does not comply with ramp requirements. The sidewalk also includes cross slopes of 3.1%.

The sidewalk providing access to Krenek Tap Road will need to be replaced to either provide a 1:20 (5%) maximum running slope or provide a compliant ramp system.

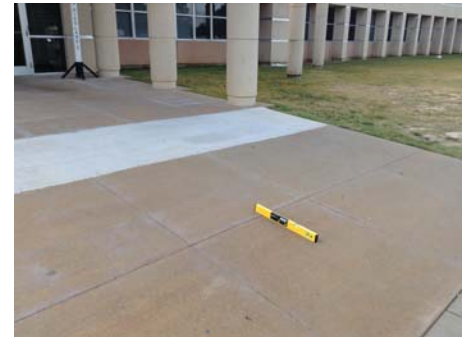
Violation #2: The concrete area leading up to the main entrance has a running slope of 8.2% and does not comply with ramp requirements.

AR Violation 2 - The concrete area leading up to the main entrance has a running slope of 8.2%.

Recommendation: The sloped area leading up to the customer entrance must either provide a running slope of 1:20 (5%) maximum or comply with ramp requirements.

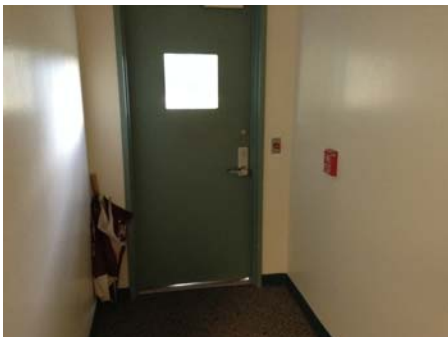
Hallway Violation 1 - Exit door from office area to exterior does not have 12" on the push side of the door.

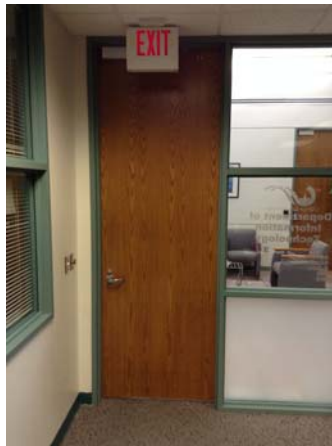
Hallway Violation 2 - 6-1/2" clearance on the push side of the door is provided where 12" minimum is required.

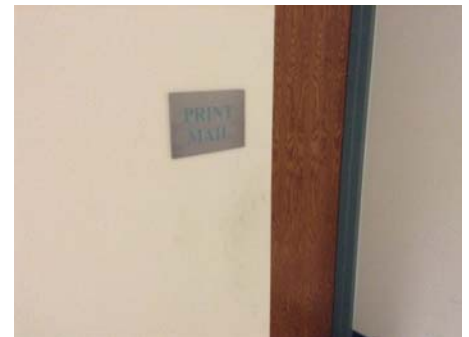
Hallway Violation 3 - The Print Mail and Employee Lunchroom signs do not include raised tactile characters or Braille.

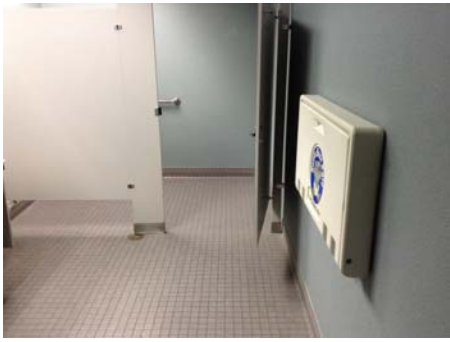
RR Violation 1 - Lobby Men Restroom - Door to accessible toilet compartment does not self-close.

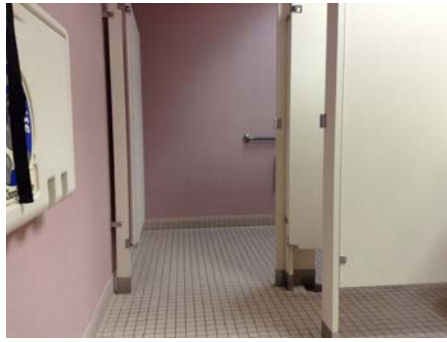
RR Violation 2 - Lobby Women Restroom - Door to accessible toilet compartment does not self-close.

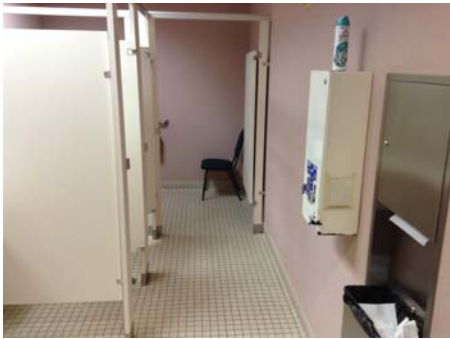
RR Violation 4 - Employee Women Restroom - Door to accessible toilet compartment does not self-close.

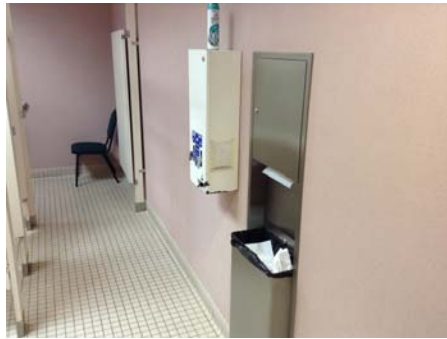
RR Violation 5 - Employee Women Restroom -The surface mounted feminine product dispenser is a protruding object as it extends 8" from the wall into the circulation path to the accessible toilet compartment.

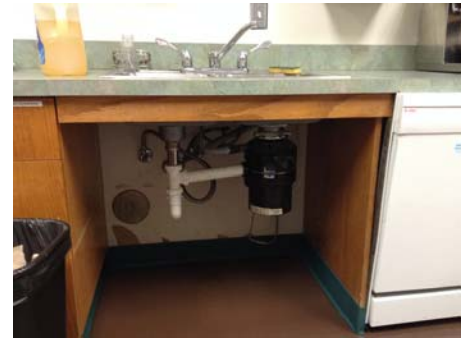
BR Violation 1,2 - Employee Lunchroom - The garbage disposal obstructs the required knee clearance under the sink. At the time of construction of this facility, a knee/toe clearance for a forward approach was required. The exposed water lines and drain pipe are not protected against contact.

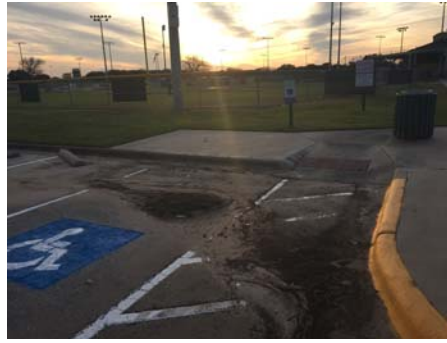
Parking Violation 1 - In the middle parking lot the van accessible parking space serving the little league fields must be restriped to meet the minimum dimensions of a van accessible parking space.

In the middle parking lot the van accessible parking space serving the little league fields must be re-striped to meet the minimum dimensions of a van accessible parking space. Both of the accessible parking spaces serving the pavilion must be restriped to meet the minimum dimensions for accessible parking spaces. It is recommended that one of these spaces be striped and signed to become a van accessible space as the only van space is on the other side of the parking lot with no accessible connecting route.

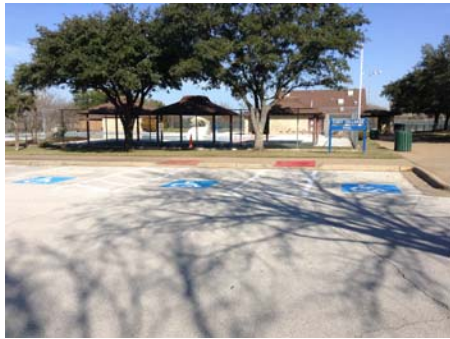
Parking Violation 1 - The three accessible parking spaces serving the pool entrance should be restriped to meet the minimum dimensions for accessible parking spaces.

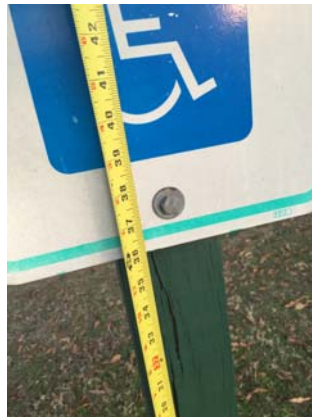
Parking Violation 2 - The parking signs are too low.

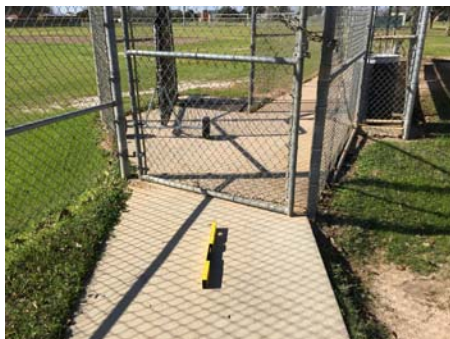
AR Violation 2 - Access into the dugouts at the west side little league fields includes running slopes approximately 7.7% and no accessible ramp is provided.

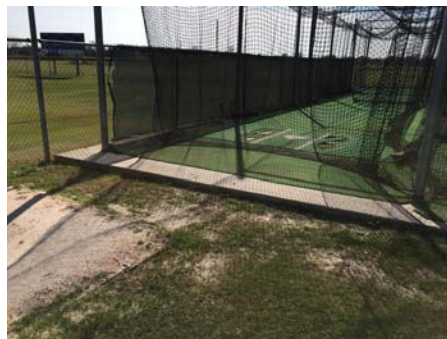
AR Violation 3 - No accessible routes are provided to any of the batting cages located between the ball fields.

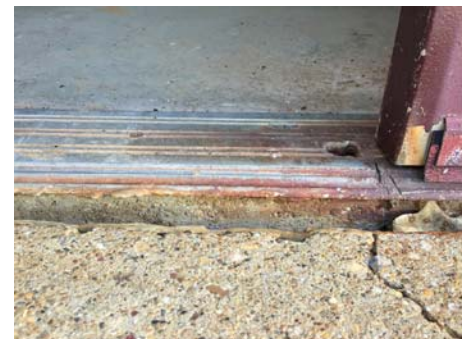
AR Violation 4 - Access into the umpires area includes a significant change in level at the door threshold and the exterior door maneuvering clearance is not level.

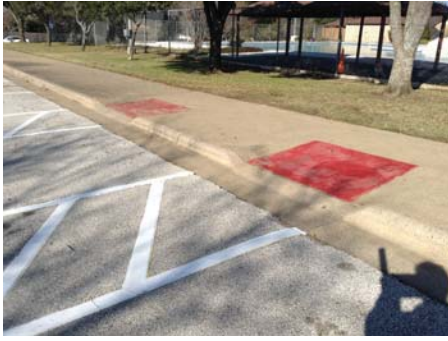
AR Violation 5 - The curb ramps serving the three accessible parking spaces at the pool are not compliant. Each has a 14% to 17% slope at the transition to the parking surface and the flares exceed the maximum 1:10 slope.

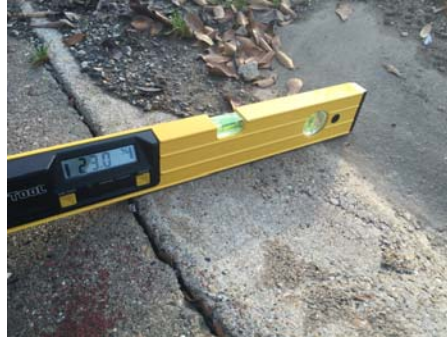
AR Violation 5 - The curb ramps serving the two accessible parking spaces at the pavilion have a 23% slope at the transition to the parking surface.

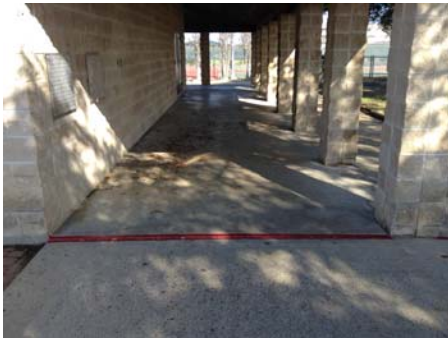
AR Violation 6 - The route at the pool from the accessible parking to the pool house entrance includes a 1" change in level.

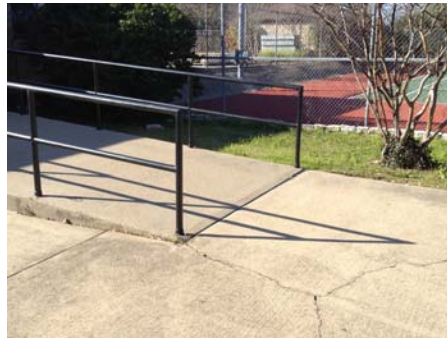
AR Violation 7 - The ramp at the rear of the pool house is not compliant. The ramp is missing the required edge protection, handrail extensions and the top landing is not level.

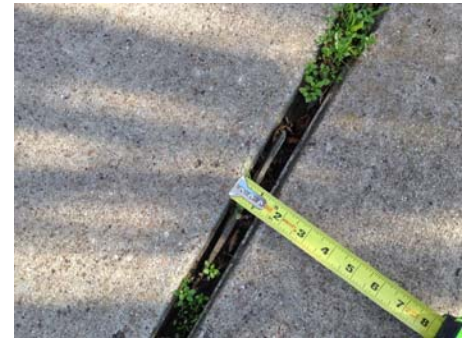
AR Violation 8 - There are large gaps of 1" or more in the expansion joints along the route from the pool house to the tennis courts.

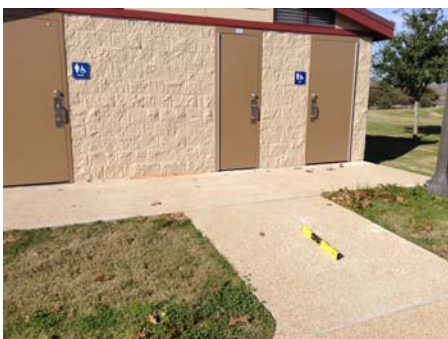
AR Violation 9 - The route to the brand new men's and women's restrooms near the tennis courts has a running slope of 10.5%.

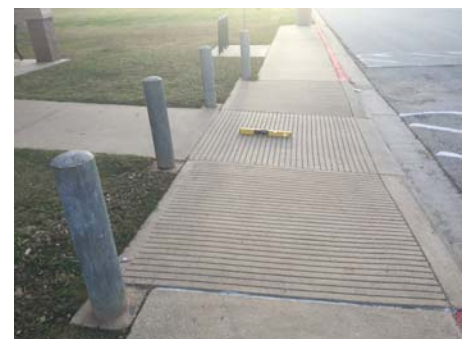
AR Violation 11 - The curb ramp landing in front of the Southwood Community Center has a cross slope of 7.1%. The route from the bicycle rack would cross this landing. This landing should be level in all directions. The sidewalk to the bicycle rack has a 3.5% cross slope.

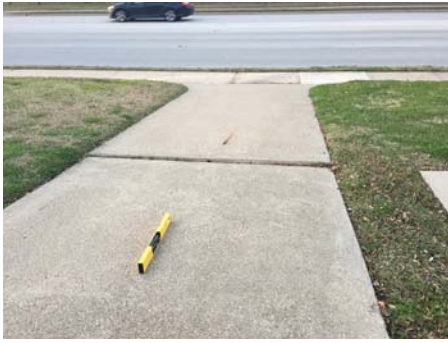
AR Violation 12 - The sidewalk in front of the pool facility that connects to the sidewalk along Rock Prairie Road has a running slope of 12%.

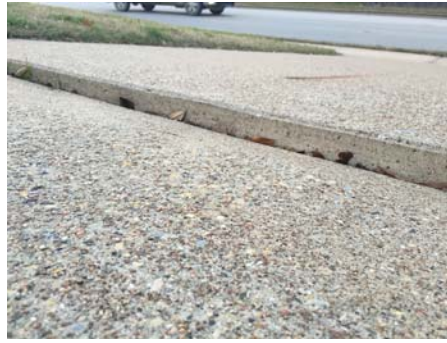
AR Violation 12 - The sidewalk in front of the pool facility that connects to the sidewalk along Rock Prairie Road has significant level changes.

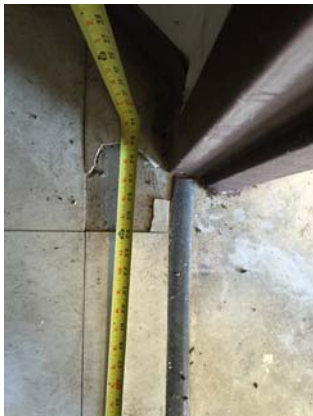
Hallway Violation 1 - The doors into the concessions areas provide only 27" clear width where 32" minimum is required.

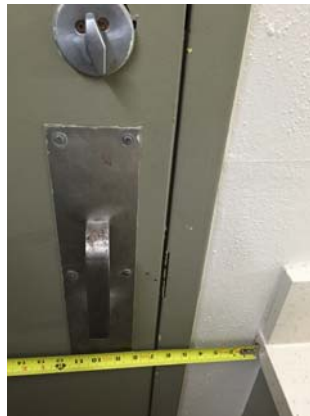
Hallway Violation 2 - The doors within the pavilion do not have the required 18" clearance on the pull side of the doors.

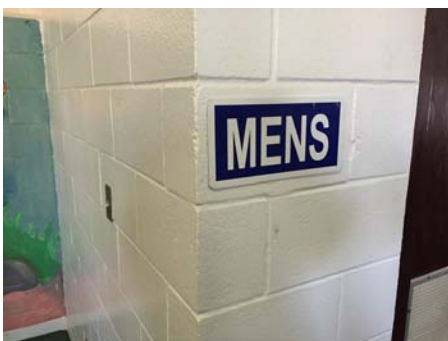
Hallway Violation 3 - The room signs within the park facilities are not accessible. Many do not include tactile characters or Braille.

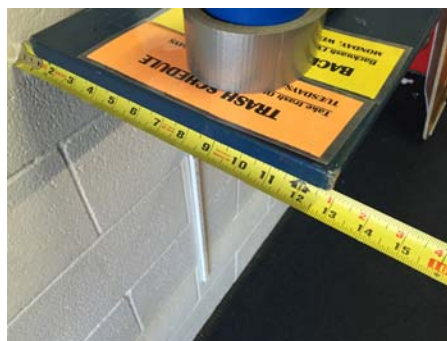
Hallway Violation 4 - The wall mounted shelving within the interior of the pool house is a protruding object.

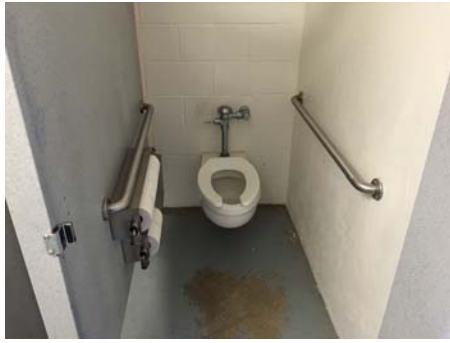
RR Violation 1 - The restrooms serving the both baseball field complexes do not include any accessible elements.

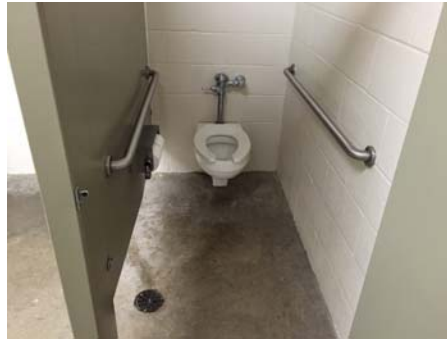
RR Violation 2 - The two restrooms serving the pavilion are not substantially compliant.

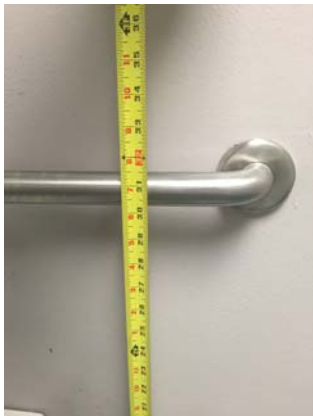
RR Violation 4 - The grab bars within the Southwood Community Center restrooms are too low at 31-1/2" to the top of the bars.

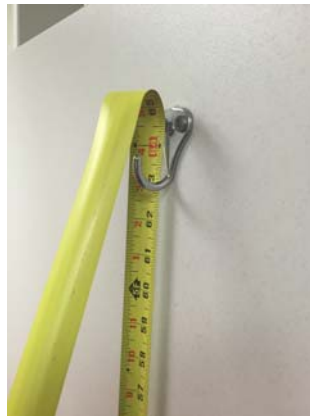
RR Violation 5 - The hooks in the accessible toilet compartments in the Southwood Community Center are too high at 64".

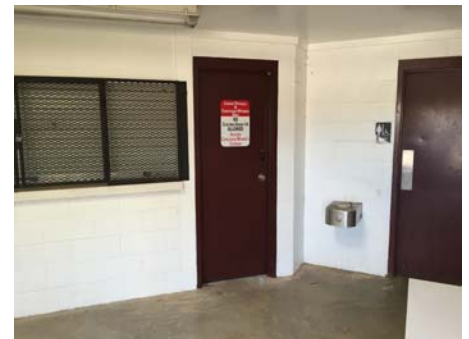
Misc Violation 1 - Concessions counters serving the little league fields are all at 43" high. The concession counters serving the pavilion are 42" high. No accessible concession counters are provided.

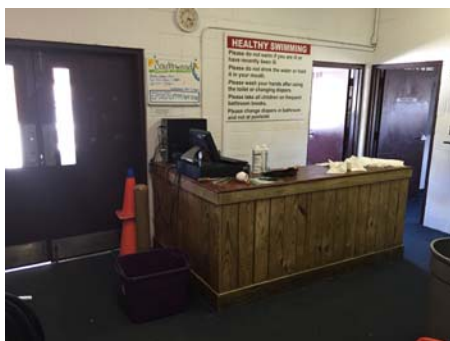
Misc Violation 1 - The pool reception counter is 38" high with no accessible portion of counter.

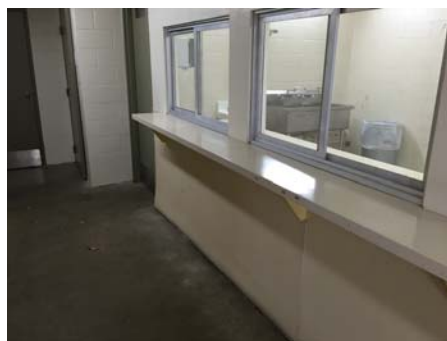
Misc Violation 1 - The pavilion concession counters are 42" high with no accessible portion of counter.

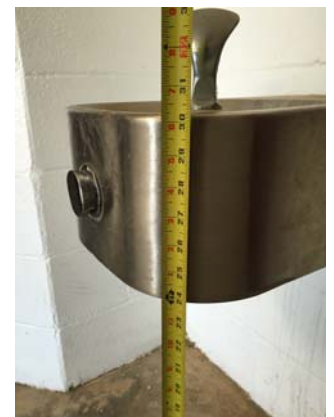
Misc Violation 2 - Only one drinking fountain is provided at each little league field complex. The units that are provided only have 24" knee clearance where 27" minimum is required. No drinking fountains for standing persons are provided.

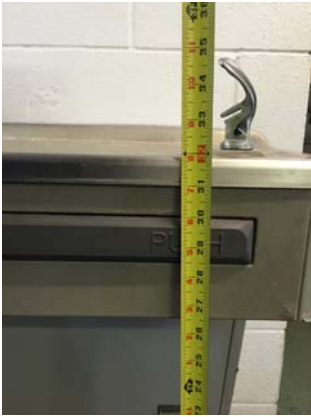
Misc Violation 2 - Only one drinking fountain is provided to serve the pool facility. No drinking fountain for standing persons is provided.

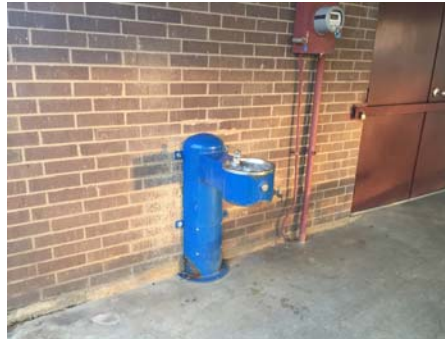
Misc Violation 2 - Only one drinking fountain is provided to serve the pavilion. The unit is accessible in terms of knee clearance. No drinking fountain for standing persons is provided.

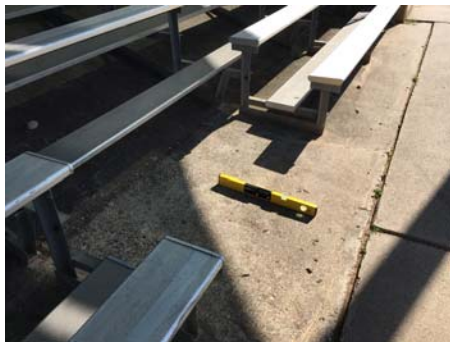
Park Violation 1 - The accessible wheelchair seating spaces serving the west side little league fields have a slope of 3.5% within the seating spaces. The wheelchair spaces at the middle little league fields have a 5% slope within the seating spaces.

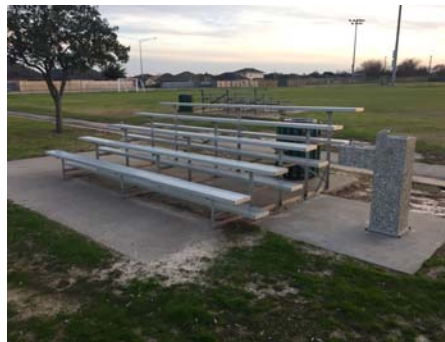
Park Violation 1 - No accessible wheelchair seating is provided within any of the soccer field bleacher seating.

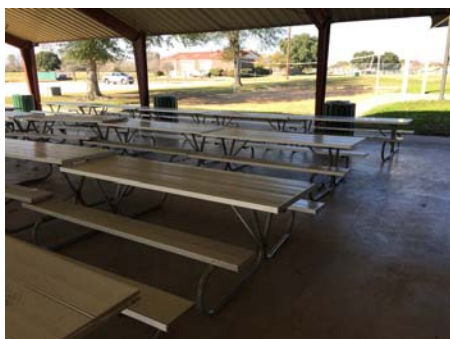
Park Violation 3 - No accessible picnic tables are provided at the pavilion.

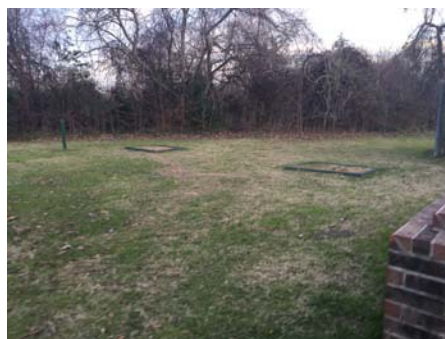
Park Violation 4 - There is no accessible route to the horseshoe pits.

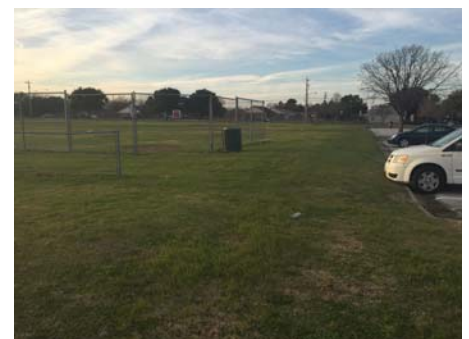
Park Violation 4 - No accessible connecting route is provided to the ball fields near the Southwood Community Center. These fields do not connect to any accessible parking or other amenities on the site.

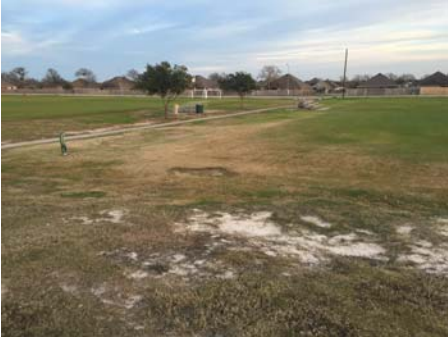
Park Violation 4 - No accessible connecting route is provided to any of the soccer fields in the southwest area of the park.

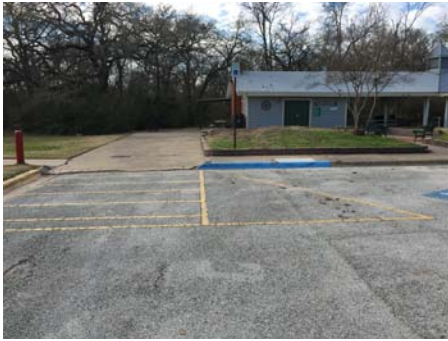
The accessible parking space serving the pavilion is missing the required "van accessible" sign. The van accessible sign must be installed below the International Symbol of Accessibility.

Parking Violation 2 - The accessible parking space serving the pavilion is missing the required "van accessible" sign. The van accessible sign must be installed below the International Symbol of Accessibility.

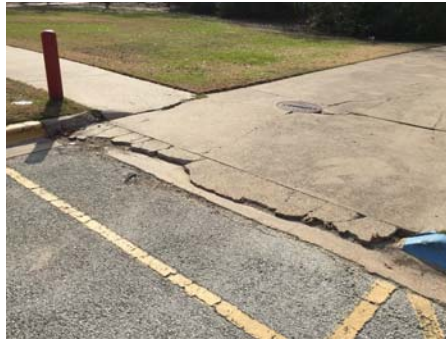
Parking Violation 3 - The curb ramp serving the pavilion accessible parking space is not compliant as it includes a level change at the bottom of the ramp.

The existing curb ramp should be replaced with a compliant curb ramp that includes a flush transition to the parking surface. Be advised that the curb ramp also serves the accessible route to the basketball court, so the ramp must either have a route around the ramp at the top of the ramp or relocated to serve both the pavilion and the basketball court.

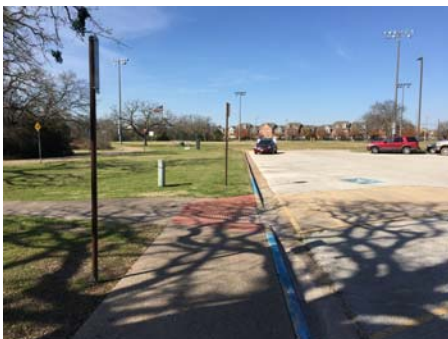
Parking Violation 5 - The non-accessible and accessible parking spaces serving the Recreation World HDQ and the tennis courts that are located at the curb line will overhang the sidewalk and reduce the clear width of the sidewalk.

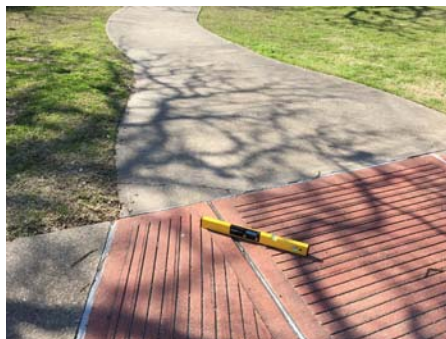
Parking Violation 6 - An accessible route is not provided around the top of the curb ramp.

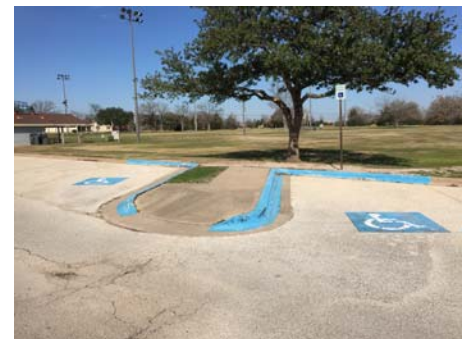
Parking Violation 7 - The two accessible parking spaces serving the soccer field area are not served by access aisles.

An access aisle must be created to serve each of the two accessible spaces. The minimum access aisle width is 60"; however, since these serve the soccer fields and there is no accessible route provided from the existing van accessible space near the tennis courts, it is recommended that one of these two spaces become van accessible and be served by a 96" wide access aisle. Van accessible signage will also need to be provided at this new van space.

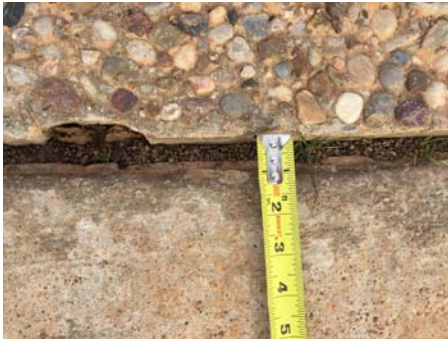
AR Violation 1 - The path of travel from the accessible parking serving the ball fields to the ball fields themselves has gaps and level changes that exceed allowable tolerances.

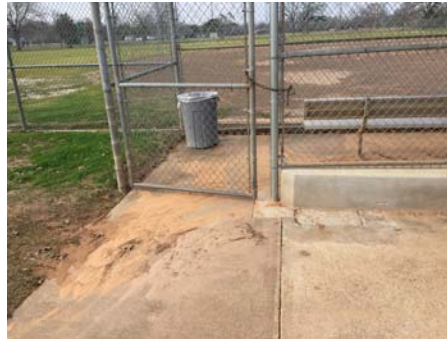
AR Violation 2 - The path of travel from the dugout to the ball fields has a level change onto the field.

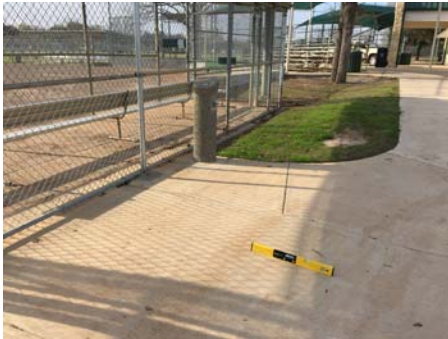
AR Violation 4 - The concrete area between the ball fields has slopes from compliant to 9.2%. This area, where people will transverse from different directions, should not exceed 2% in any direction.

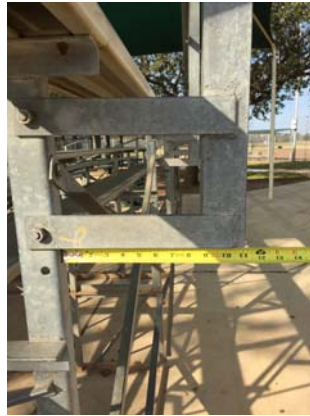
AR Violation 5 - The area around the bleachers has protruding objects very dangerous to a person with little or no vision, or to anyone not paying attention. They protrude out 11" at 59" height.

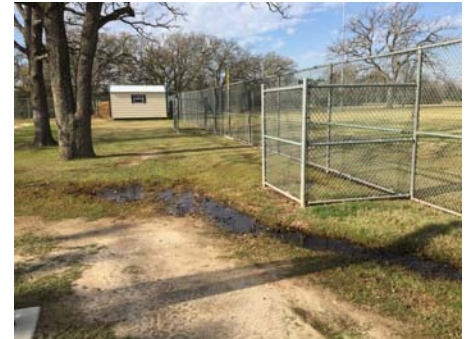
AR Violation 6 - There is no accessible route to the bull pens.

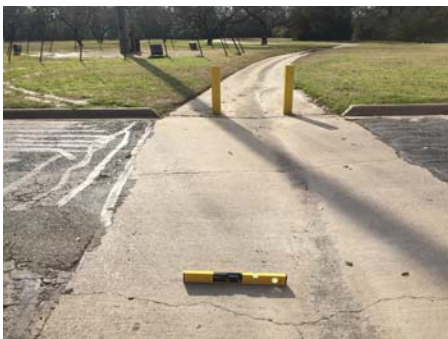
AR Violation 7 - The entire path have a cross slope issue far above reasonable tolerances. In some cases the cross slope is 7.1%.

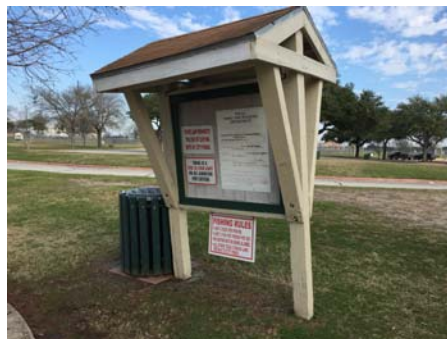
AR Violation 8 - The area around the information sign has protruding objects dangerous to a person with little or no vision.

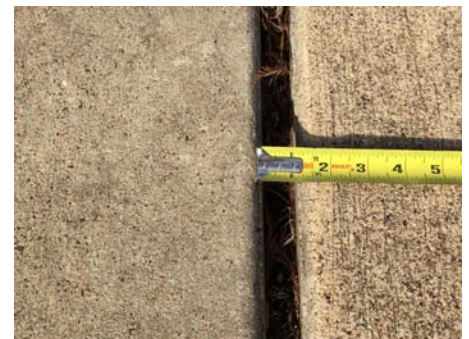
AR Violation 9 - On the south side of Central Park Ln. the path of travel also has gaps and level changes that exceed allowable tolerances.

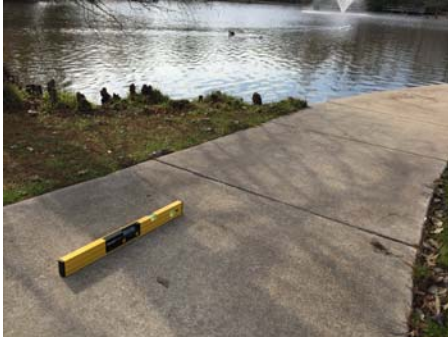
AR Violation 10 - The running slope of the path that goes around the Wayne Bryan Bike Loop exceeds 5% in several areas.

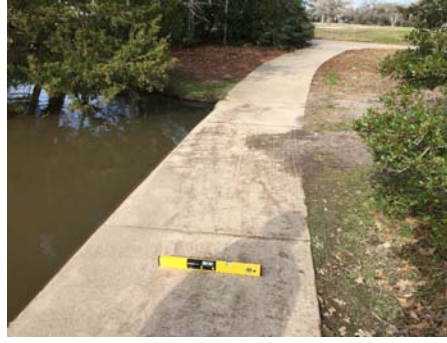
AR Violation 11 - The cross slope is 2.6% - 4.7% where 2% maximum is required.

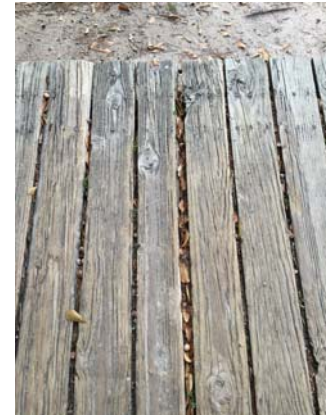
AR Violation 12 - The sidewalk on the south side of the lake, west of the little storage building, is connected by wood path connections that have gaps between the panels.

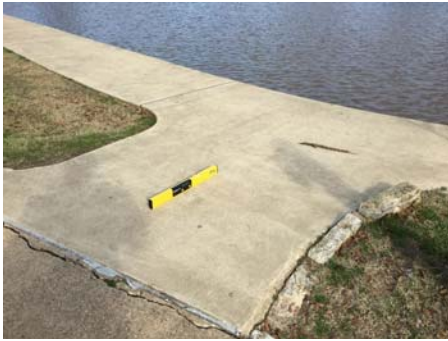
AR Violation 13 - The connection from the dock area back to the sidewalk has a running slope of 6%. This qualifies as a ramp, but more importantly it ends at the water. Without handrails to hold onto, a person using this route could easily end up in the water.

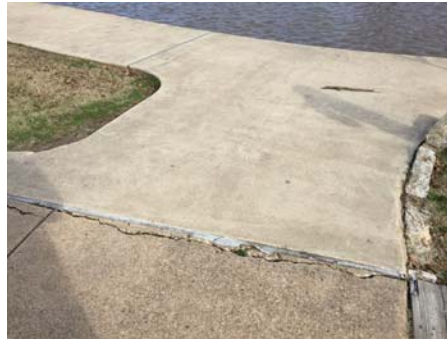
AR Violation 14 - The connection from the dock area back to the sidewalk has broken concrete and a gap at the expansion joint.

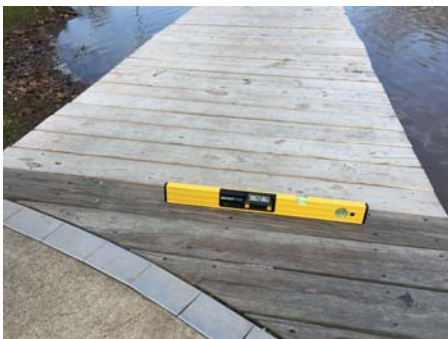
AR Violation 16 - The cross slope of the wood bridge that crosses the lake/pond on the west side is up to 4.2% .

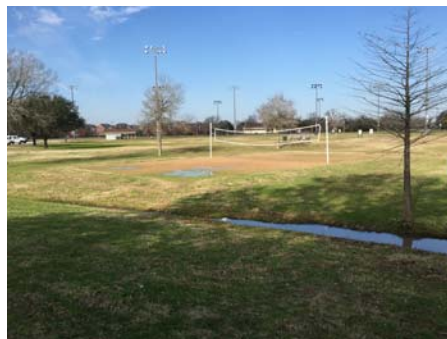
AR Violation 17 - There is no accessible route to the edge of the sand volleyball court.

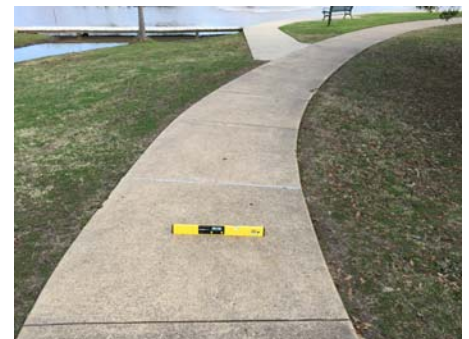
AR Violation 18 - The cross slope of the sidewalk between the sand volleyball court and the basketball court is up to 4.6%. The running slope goes up to 7.1% but is not treated as a ramp. Any slope above 5% is, by definition, a ramp.

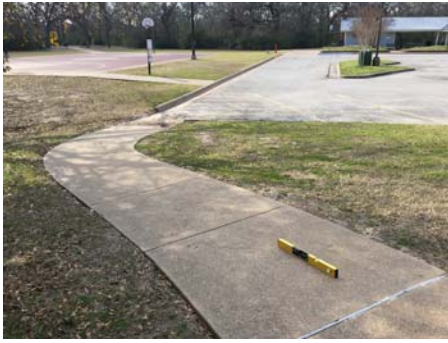
AR Violation 19 - The path of travel from the sand volleyball court to the basketball court ends in a parking lot with no accessible connection.

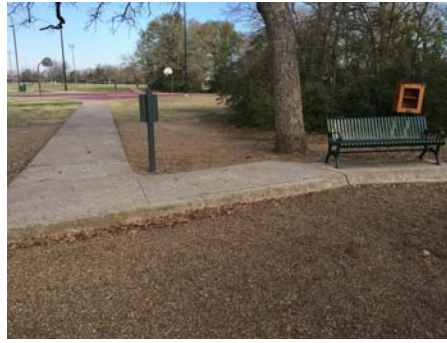
AR Violation 20 - There is a sidewalk that leads to the playground. There is no route to get into the playground area. The sidewalk dead ends at the edge of the playground.

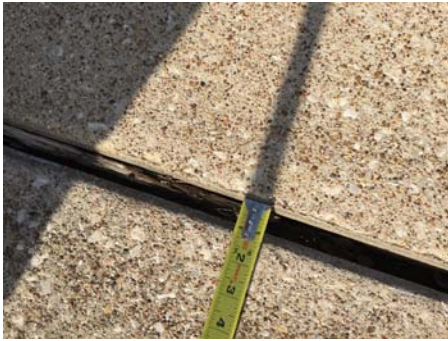
AR Violation 22 - The sidewalk from the playground to the Rec building has gaps at the expansion joints that are more than 1/2" wide. Some up to 1.5".

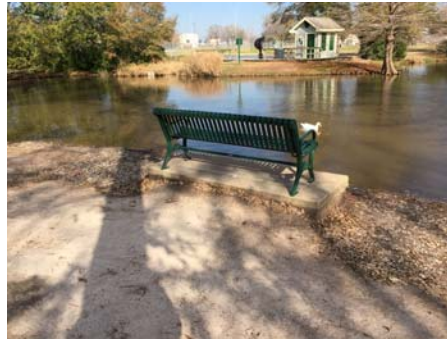
AR Violation 23 - No accessible route is provided to the benches by the water.

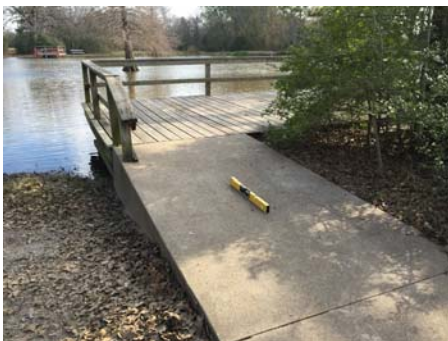
AR Violation 25 - The running slope of the concrete path that leads to the dock on the south side of the lake/pond is 5.9% but has no handrails or edge protection.

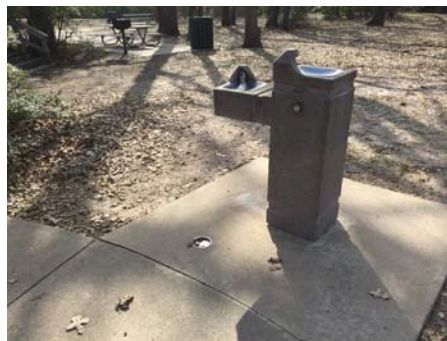
AR Violation 26 - There is a level change in the required clear floor space for the drinking fountain at the south side of the lake/pond.

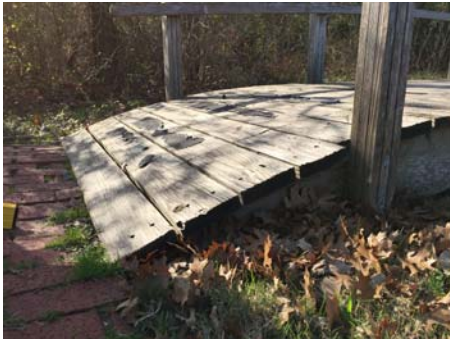
AR Violation 28 - The bridge between the pavilion and the rec building has level changes, sinking bricks and dangerously steep slopes up to 35.0%. This is the highest priority on the property.

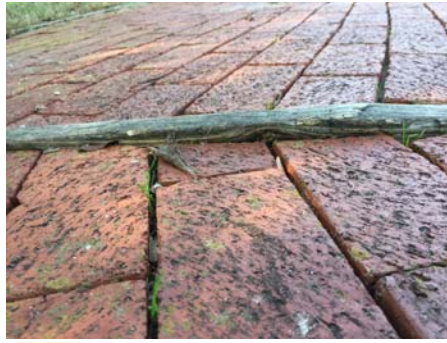
AR Violation 29 - Level changes greater than 1/4" exist along route between pavilion and Parks and Rec building.

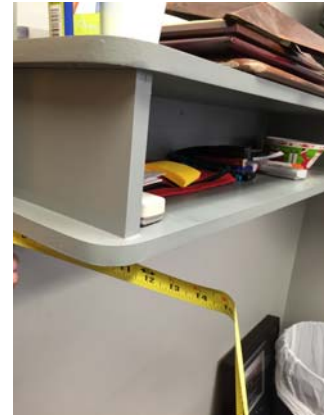
AR Violation 30 - Shelves in the work room in the Tourist Center protrude 11 1/2" at 52" in height.

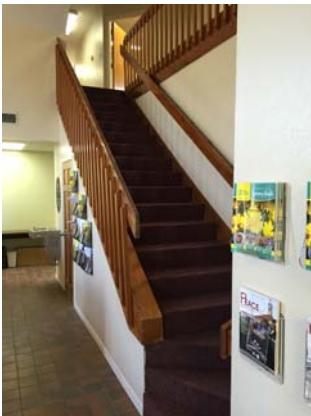
AR Violation 31/32 - There is no elevator to the second floor of the Recreation World HDQ. The stairs to the second floor of the Recreation World HDQ do not have compliant handrails.

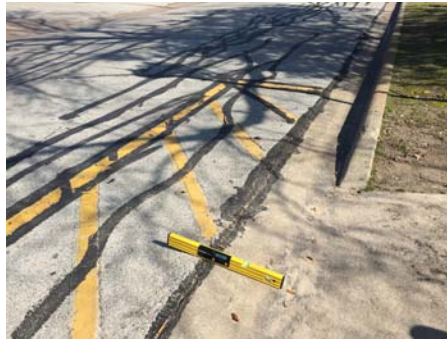
AR Violation 34 - Where the Wayne Bryan Bike Loop cross the street, it has slopes up to 12.9% and is especially steep on both sides of the street.

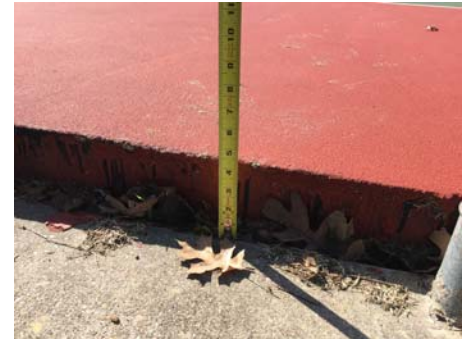
AR Violation 35 - There is a 4 1/2" level change to get into the Tennis Courts.

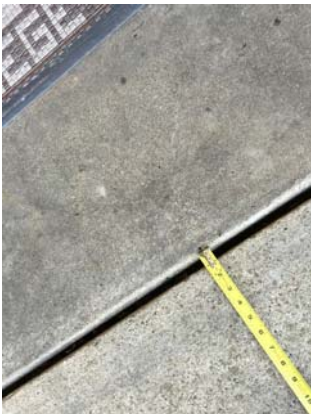
Entrance Violation 1 - There is a gap in the expansion joint directly in front of the main entrance that is 1" wide. This could catch the front wheel of a wheelchair or trip someone using a walker.

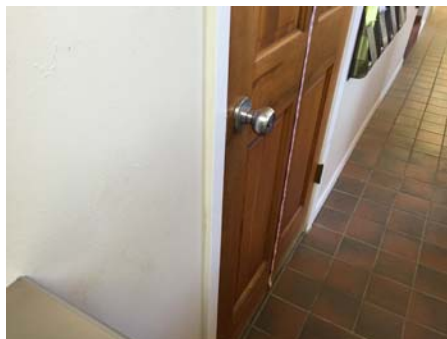
Hallway Violation 1 - Door knobs are used throughout the Tourist information building.

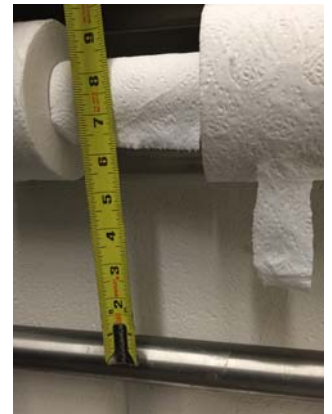
RR Violation 1 - Ballfield Restrooms- Both the men's and the women's have the toilet paper mounted about 6" above the grab bar. If above the grab bar it must be at least 12" above it so it doesn't obstruct the use of it.

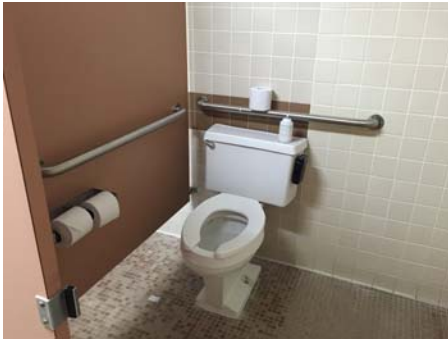
RR Violation 2 - The women's room inside the Recreation World HDQ has the flush control on the wrong side.

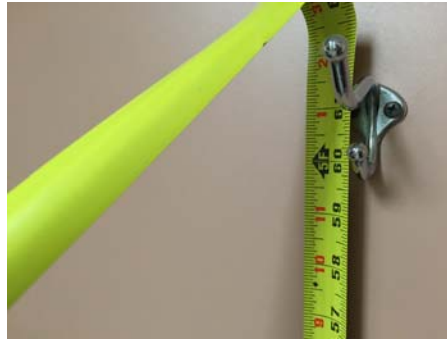
RR Violation 3 - The coat hook in the accessible stall in both the men's and women's restrooms are mounted at 60" above the finished floor.

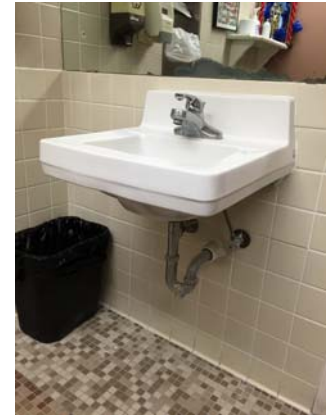
RR Violation 4 - The pipes underneath the lavatories in both the men's and women's restrooms, on both floors, are not wrapped or protected from contact.

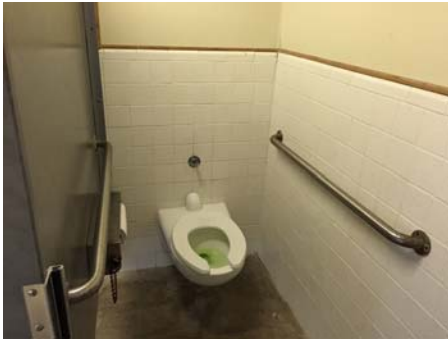
RR Violation 5 - The men's and women's restrooms serving the pavilion do not have compliant stalls, doors, urinals or lavatories.

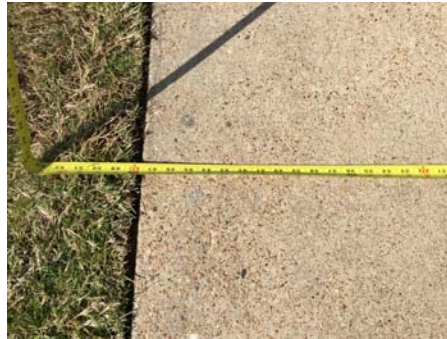
RR Violation 6 - The men's and women's restrooms serving the tennis courts do not have compliant maneuvering clearance on the doors but are otherwise substantially compliant.

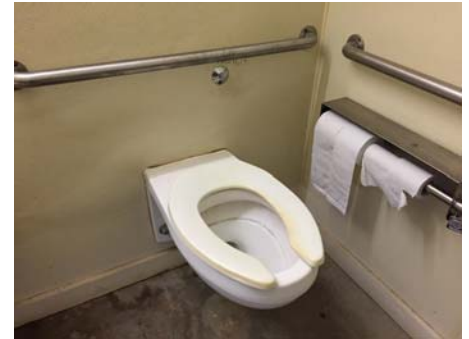
RR Violation 7 - The men's room serving the tennis courts has the flush control on the wrong side.

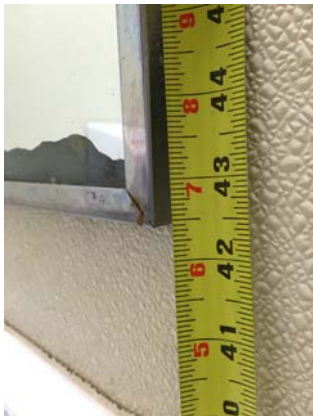
RR Violation 8 - The mirrors in the men's and women's restrooms serving the tennis courts are mounted above 40" to the bottom of the reflecting surface.

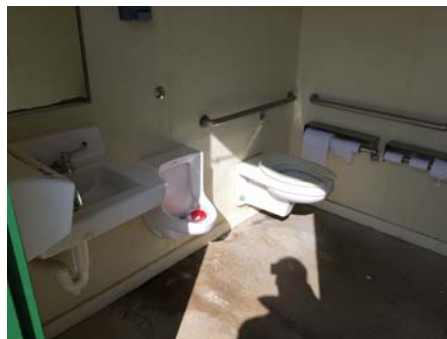
RR Violation 9 - The urinal is not permitted to be located within 60" of the water closet sidewall.

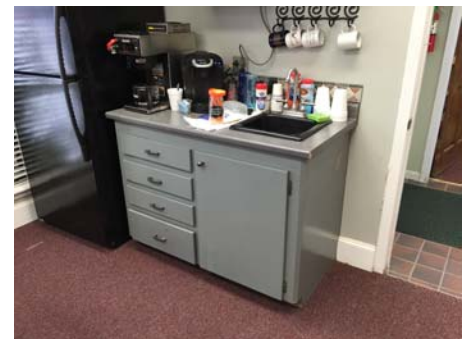
Break Room Violation 1 -The counter in the break room is mounted at 36" aff.
