## **Appendices (Provided on CD)**

Appendix D: Self-Evaluation Reports

## City of College Station ADA Self-Evaluation and Transition Plan

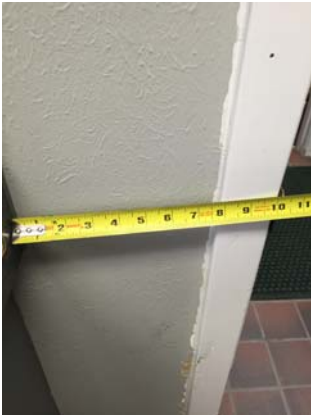
Break Room Violation 2 - The door maneuvering clearance for the break room door is only 10" on the pull side of the door. 18" is required.

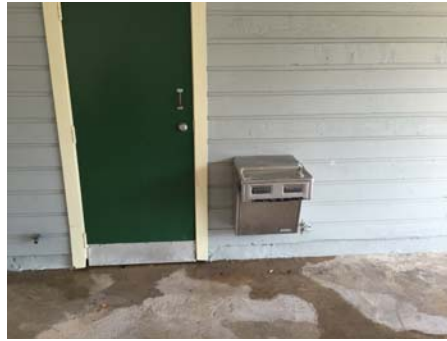
Misc Violation 1 - The drinking fountains on the south side of Central Park Ln. do not comply.

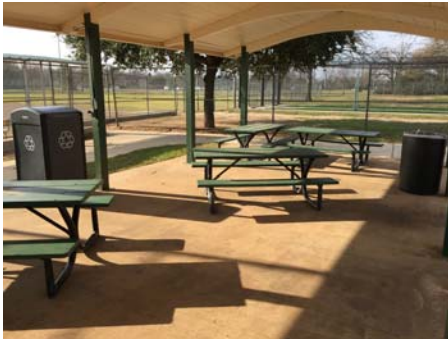
Park Violation 1 - No accessible picnic tables were noted at any of the pavilions.

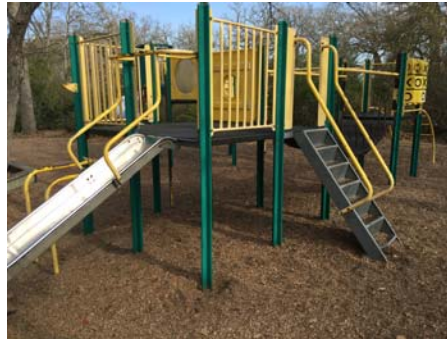
Park Violation 2 - The playground does not include accessible playground equipment.

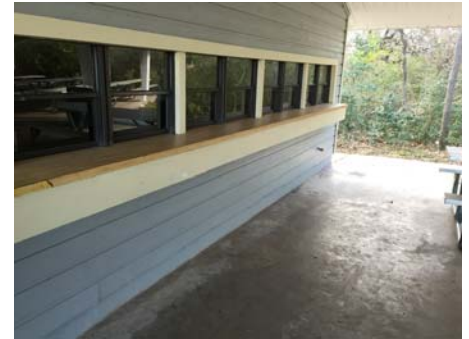
Park Violation 3 - The concession stand attached to the Rec building has counters that are 42" high with no lowered counter.

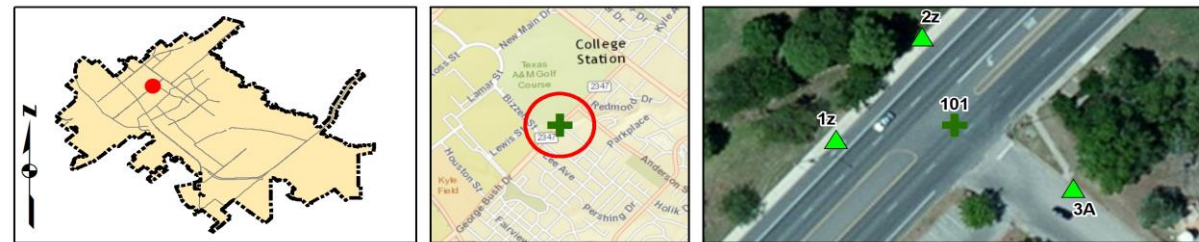
Intersection Issues	Crosswalk				Recommendations
	N	E	S	W	
Path of travel pavement condition	N/A	N/A	Dangerous	N/A	Repave roadway and install crosswalk pavement markings
Path of travel running slope is greater than 5%					
Path of travel cross slope is greater than 2% for stop control approaches	N/A	N/A	X	N/A	
Path of travel cross slope is greater than 5% for free-flow approaches	N/A	N/A	N/A	N/A	Install crosswalk pavement markings
Crosswalk width is less than 6'	N/A	N/A	N/A	N/A	
Crosswalk striping condition	N/A	N/A	None	N/A

Curb Ramp Issues	Curb Ramp ID ('z' or 'l' in ramp label indicates no existing ramp)			Recommendations
	1z	2z	3A	
Curb ramp does not exist and is needed				Remove and replace curb ramp
Curb ramp does not land in crosswalk				
No 4' x 4' clear space at base of curb ramp				
Curbed side is not 90° or has traversable adjacent surface		X		
Flare cross slope is greater than 10%				
Curb ramp running slope is greater than 8.33%				
Blended transition running slope is greater than 5%				
Cut-thru ramp running slope is greater than 5%				
Curb ramp cross slope is greater than 2%				
Cut-thru ramp cross slope is greater than 2%				
Curb ramp width is less than 48"				For intersection ramps and commercial driveway ramps, install color truncated domes
Cut-thru ramp width is less than 60"				
Permanent obstruction (>0.25") in curb ramp/landing/flares		X		
Temporary obstruction (>0.25") in curb ramp/landing/flares				Remove and replace landing area

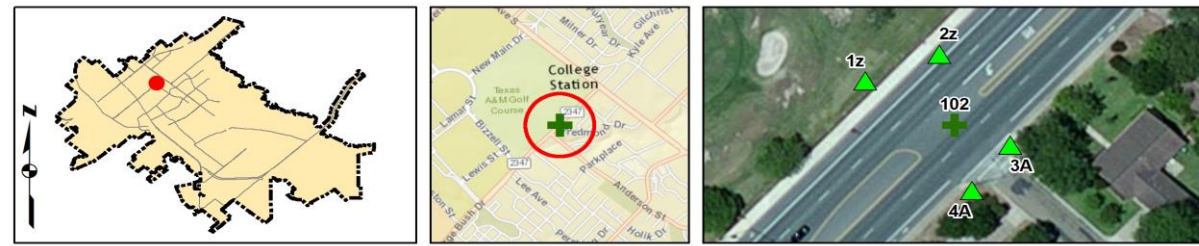
Intersection Issues	Crosswalk				Recommendations
	N	E	S	W	
Path of travel pavement condition	N/A	N/A	Dangerous	N/A	Repave roadway and install crosswalk pavement markings
Path of travel running slope is greater than 5%					
Path of travel cross slope is greater than 2% for stop control approaches	N/A	N/A	X	N/A	
Path of travel cross slope is greater than 5% for free-flow approaches	N/A	N/A	N/A	N/A	Remove and replace crosswalk pavement markings
Crosswalk width is less than 6'	N/A	N/A	N/A	N/A	
Crosswalk striping condition	N/A	N/A	Worn	N/A

Curb Ramp Issues	Curb Ramp ID ('z' or 'l' in ramp label indicates no existing ramp)				Recommendations
	1z	2z	3A	4A	
Curb ramp does not exist and is needed					Remove and replace curb ramp
Curb ramp does not land in crosswalk					
No 4' x 4' clear space at base of curb ramp					
Curbed side is not 90° or has traversable adjacent surface		X	X		
Flare cross slope is greater than 10%					
Curb ramp running slope is greater than 8.33%					
Blended transition running slope is greater than 5%					
Cut-thru ramp running slope is greater than 5%					
Curb ramp cross slope is greater than 2%		X	X		
Cut-thru ramp cross slope is greater than 2%					
Curb ramp width is less than 48"		X	X		For intersection ramps and commercial driveway ramps, install color truncated domes
Cut-thru ramp width is less than 60"					
Permanent obstruction (>0.25") in curb ramp/landing/flares					
Temporary obstruction (>0.25") in curb ramp/landing/flares

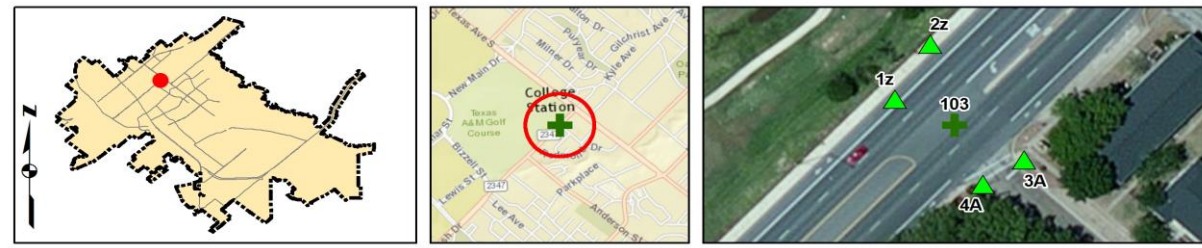
Intersection Issues	Crosswalk				Recommendations
	N	E	S	W	
Path of travel pavement condition	N/A	N/A	Good	N/A	
Path of travel running slope is greater than 5%					
Path of travel cross slope is greater than 2% for stop control approaches	N/A	N/A	X	N/A	Repace roadway and install crosswalk pavement markings
Path of travel cross slope is greater than 5% for free-flow approaches	N/A	N/A	N/A	N/A	
Crosswalk width is less than 6'	N/A	N/A	N/A	N/A	Install crosswalk pavement markings
Crosswalk striping condition	N/A	N/A	None	N/A

Curb Ramp Issues	Curb Ramp ID ('z' or 'l' in ramp label indicates no existing ramp)				Recommendations
	1z	2z	3A	4A	
Curb ramp does not exist and is needed					
Curb ramp does not land in crosswalk					
No 4' x 4' clear space at base of curb ramp					
Curb side is not 90° or has traversable adjacent surface			X		
Flare cross slope is greater than 10%					
Curb ramp running slope is greater than 8.33%					
Blended transition running slope is greater than 5%					
Cut-thru ramp running slope is greater than 5%					
Curb ramp cross slope is greater than 2%		X	X		Remove and replace curb ramp
Cut-thru ramp cross slope is greater than 2%					
Curb ramp width is less than 48"		X	X		
Cut-thru ramp width is less than 60"					
Permanent obstruction (>0.25") in curb ramp/landing/flares					
Temporary obstruction (>0.25") in curb ramp/landing/flares					
No textured surface at base of curb ramp		X	X		For intersection ramps and commercial driveway ramps, install color truncated domes

No color contrast at base of curb ramp		X	X		
Landing area does not exist and is needed					
Landing area is less than 5' x 5' or slopes greater than 2%		X	X		Remove and replace landing area
Curb ramp transition onto roadway is greater than 0.25"					
Counter slope of the gutter or street at the foot of the curb ramp is greater than 5%			X		Fix curb ramp counter slope
Ponding occurs at base of curb ramp				X	Fix ponding

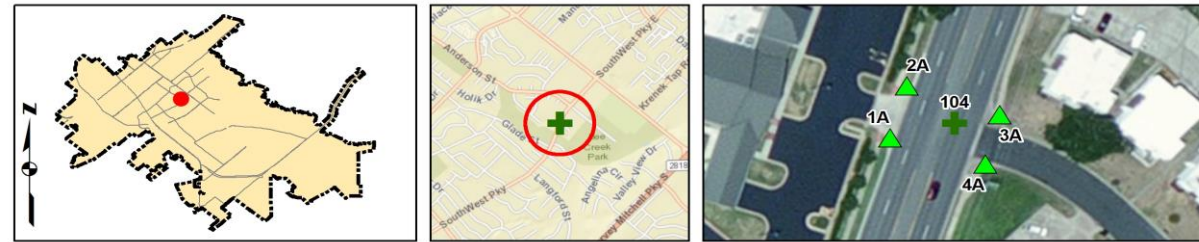
Intersection Issues	Crosswalk				Recommendations
	N	E	S	W	
Path of travel pavement condition	Good	N/A	Good	N/A	
Path of travel running slope is greater than 5%					
Path of travel cross slope is greater than 2% for stop control approaches		N/A	X	N/A	Repare roadway and install crosswalk pavement markings
Path of travel cross slope is greater than 5% for free-flow approaches	N/A	N/A	N/A	N/A	
Crosswalk width is less than 6'	N/A	N/A	N/A	N/A	Install crosswalk pavement markings
Crosswalk striping condition	None	N/A	None	N/A

Curb Ramp Issues	Curb Ramp ID ('z' or 'l' in ramp label indicates no existing ramp)				Recommendations
	1A	2A	3A	4A	
Curb ramp does not exist and is needed			X		Remove and replace crosswalk pavement markings
Curb ramp does not land in crosswalk			X		
No 4' x 4' clear space at base of curb ramp			X	X	Remove and replace curb ramp
Curb side is not 90° or has traversable adjacent surface			X	X	
Flare cross slope is greater than 10%		X	X		
Curb ramp running slope is greater than 8.33%		X	X		
Blended transition running slope is greater than 5%					
Cut-thru ramp running slope is greater than 5%		X	X	X	
Curb ramp cross slope is greater than 2%	X	X	X	X	Remove temporary obstruction
Cut-thru ramp cross slope is greater than 2%	X	X	X	X	
Curb ramp width is less than 48"	X	X	X	X	For intersection ramps and commercial driveway ramps, install color truncated domes
Cut-thru ramp width is less than 60"			X		
Permanent obstruction (>0.25") in curb ramp/landing/flares			X		Remove and replace landing area

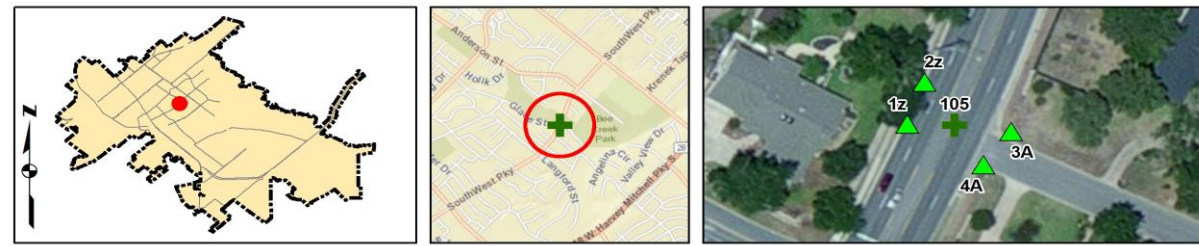
Intersection Issues	Crosswalk				Recommendations
	N	E	S	W	
Path of travel pavement condition	N/A	N/A	Dangerous	N/A	Repave roadway and install crosswalk pavement markings
Path of travel running slope is greater than 5%					
Path of travel cross slope is greater than 2% for stop control approaches	N/A	N/A		N/A	
Path of travel cross slope is greater than 5% for free-flow approaches	N/A	N/A	N/A	N/A	
Crosswalk width is less than 6'	N/A	N/A	N/A	N/A	Install crosswalk pavement markings
Crosswalk striping condition	N/A	N/A	None	N/A

Curb Ramp Issues	Curb Ramp ID ('z' or 'l' in ramp label indicates no existing ramp)				Recommendations
	1z	2z	3A	4A	
Curb ramp does not exist and is needed					
Curb ramp does not land in crosswalk					
No 4' x 4' clear space at base of curb ramp					
Curbed side is not 90° or has traversable adjacent surface		X	X		
Flare cross slope is greater than 10%					
Curb ramp running slope is greater than 8.33%			X		
Blended transition running slope is greater than 5%					
Cut-thru ramp running slope is greater than 5%					
Curb ramp cross slope is greater than 2%		X	X		
Cut-thru ramp cross slope is greater than 2%					
Curb ramp width is less than 48"		X	X		
Cut-thru ramp width is less than 60"					
Permanent obstruction (>0.25") in curb ramp/landing/flares		X			
Temporary obstruction (>0.25") in curb ramp/landing/flares					
No textured surface at base of curb ramp		X	X		
No color contrast at base of curb ramp		X	X

Remove and replace curb ramp

Remove and replace landing area

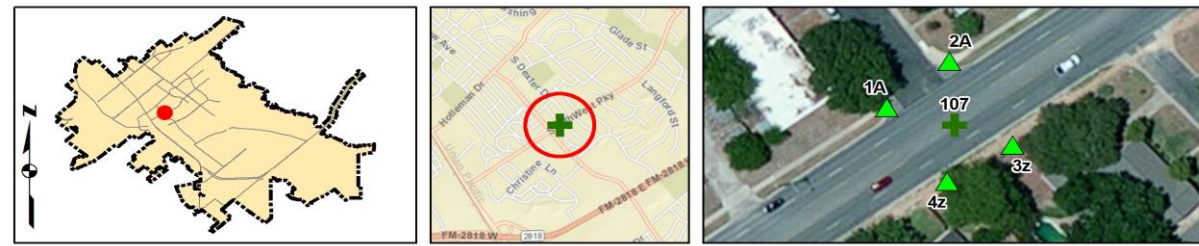
Intersection Issues	Crosswalk				Recommendations
	N	E	S	W	
Path of travel pavement condition	Dangerous	Good	N/A	Good	Repare roadway and install crosswalk pavement markings
Path of travel running slope is greater than 5%					
Path of travel cross slope is greater than 2% for stop control approaches	X	N/A	N/A	N/A	
Path of travel cross slope is greater than 5% for free-flow approaches	N/A	N/A	N/A	N/A	Install crosswalk pavement markings
Crosswalk width is less than 6'	N/A	N/A	N/A	N/A	
Crosswalk striping condition	None	None	N/A	None

Curb Ramp Issues	Curb Ramp ID ('Z' or 'I' in ramp label indicates no existing ramp)				Recommendations
	1A	2A	3Z	4Z	
Curb ramp does not exist and is needed			X	X	Install curb ramp
Curb ramp does not land in crosswalk					
No 4' x 4' clear space at base of curb ramp					
Curbed side is not 90° or has traversable adjacent surface					Remove and replace curb ramp
Flare cross slope is greater than 10%					
Curb ramp running slope is greater than 8.33%					
Blended transition running slope is greater than 5%					
Cut-thru ramp running slope is greater than 5%					
Curb ramp cross slope is greater than 2%	X	X			
Cut-thru ramp cross slope is greater than 2%					
Curb ramp width is less than 48"					
Cut-thru ramp width is less than 60"					
Permanent obstruction (>0.25") in curb ramp/landing/flares					
Temporary obstruction (>0.25") in curb ramp/landing/flares					For intersection ramps and commercial driveway ramps, install color truncated domes

No textured surface at base of curb ramp	X	X			
No color contrast at base of curb ramp	X	X			Remove and replace landing area
Landing area does not exist and is needed					
Landing area is less than 5' x 5' or slopes greater than 2%	X	X			Fix ponding
Curb ramp transition onto roadway is greater than 0.25"					
Counter slope of the gutter or street at the foot of the curb ramp is greater than 5%					
Ponding occurs at base of curb ramp	X

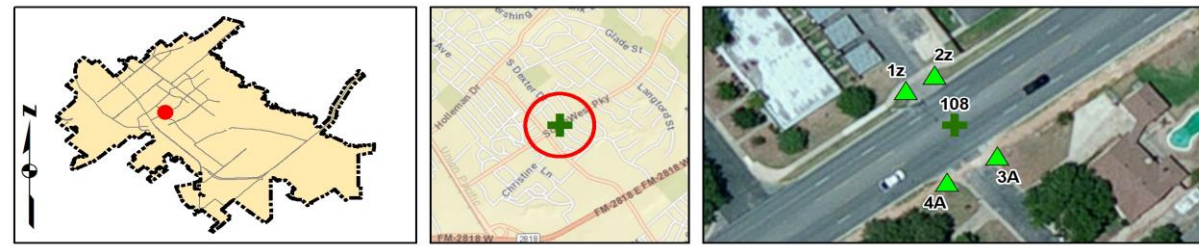
Intersection Issues	Crosswalk				Recommendations
	N	E	S	W	
Path of travel pavement condition	Good	N/A	Good	N/A	
Path of travel running slope is greater than 5%					
Path of travel cross slope is greater than 2% for stop control approaches	X	N/A		N/A	Repace roadway and install crosswalk pavement markings
Path of travel cross slope is greater than 5% for free-flow approaches	N/A	N/A	N/A	N/A	
Crosswalk width is less than 6'	N/A	N/A	N/A	N/A	Install crosswalk pavement markings
Crosswalk striping condition	None	N/A	None	N/A

Curb Ramp Issues	Curb Ramp ID ('z' or 'l' in ramp label indicates no existing ramp)				Recommendations
	1z	2z	3A	4A	
Curb ramp does not exist and is needed					
Curb ramp does not land in crosswalk					
No 4' x 4' clear space at base of curb ramp					
Curbed side is not 90° or has traversable adjacent surface					
Flare cross slope is greater than 10%					
Curb ramp running slope is greater than 8.33%					
Blended transition running slope is greater than 5%					
Cut-thru ramp running slope is greater than 5%					
Curb ramp cross slope is greater than 2%			X		Remove and replace curb ramp
Cut-thru ramp cross slope is greater than 2%					
Curb ramp width is less than 48"					
Cut-thru ramp width is less than 60"					
Permanent obstruction (>0.25") in curb ramp/landing/flares					
Temporary obstruction (>0.25") in curb ramp/landing/flares					
No textured surface at base of curb ramp					
No color contrast at base of curb ramp

Landing area does not exist and is needed					
Landing area is less than 5' x 5' or slopes greater than 2%		X	X		Remove and replace landing area
Curb ramp transition onto roadway is greater than 0.25"					
Counter slope of the gutter or street at the foot of the curb ramp is greater than 5%					
Ponding occurs at base of curb ramp			X		Fix ponding

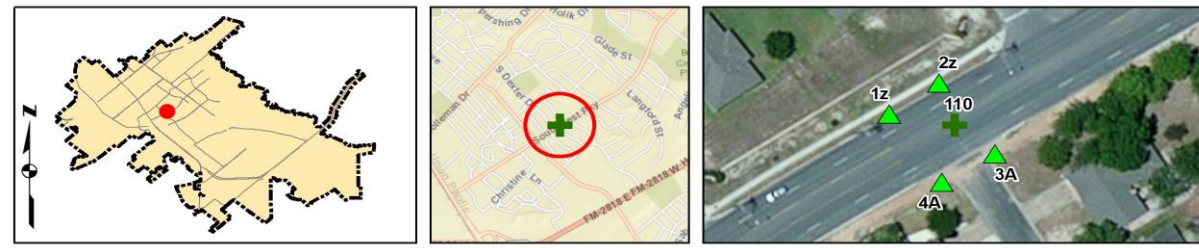
Intersection Issues	Crosswalk				Recommendations
	N	E	S	W	
Path of travel pavement condition	N/A	N/A	Poor	N/A	Repare roadway and install crosswalk pavement markings
Path of travel running slope is greater than 5%					
Path of travel cross slope is greater than 2% for stop control approaches	N/A	N/A	X	N/A	
Path of travel cross slope is greater than 5% for free-flow approaches	N/A	N/A	N/A	N/A	Install crosswalk pavement markings
Crosswalk width is less than 6'	N/A	N/A	N/A	N/A	
Crosswalk striping condition	N/A	N/A	None	N/A

Curb Ramp Issues	Curb Ramp ID ('z' or 'l' in ramp label indicates no existing ramp)				Recommendations
	1z	2z	3A	4A	
Curb ramp does not exist and is needed					Remove and replace curb ramp
Curb ramp does not land in crosswalk					
No 4' x 4' clear space at base of curb ramp					
Curbed side is not 90° or has traversable adjacent surface			X		
Flare cross slope is greater than 10%					
Curb ramp running slope is greater than 8.33%					
Blended transition running slope is greater than 5%					
Cut-thru ramp running slope is greater than 5%					
Curb ramp cross slope is greater than 2%		X			
Cut-thru ramp cross slope is greater than 2%					
Curb ramp width is less than 48"					
Cut-thru ramp width is less than 60"					
Permanent obstruction (>0.25") in curb ramp/landing/flares					
Temporary obstruction (>0.25") in curb ramp/landing/flares					
No textured surface at base of curb ramp					
No color contrast at base of curb ramp					Remove and replace landing area

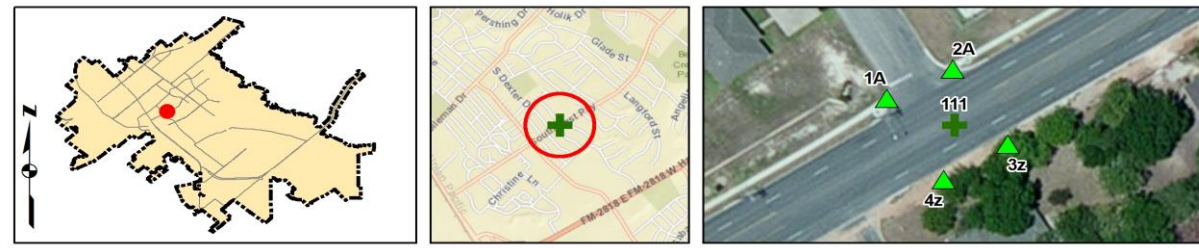
Intersection Issues	Crosswalk				Recommendations
	N	E	S	W	
Path of travel pavement condition	Good	N/A	N/A	N/A	
Path of travel running slope is greater than 5%					
Path of travel cross slope is greater than 2% for stop control approaches		N/A	N/A	N/A	
Path of travel cross slope is greater than 5% for free-flow approaches	N/A	N/A	N/A	N/A	
Crosswalk width is less than 6'	N/A	N/A	N/A	N/A	
Crosswalk striping condition	None	N/A	N/A	N/A	Install crosswalk pavement markings

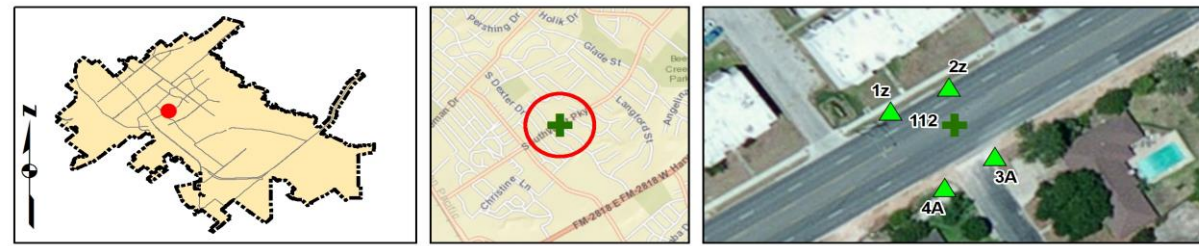
Intersection Issues	Crosswalk				Recommendations
	N	E	S	W	
Path of travel pavement condition	N/A	N/A	Dangerous	N/A	Repave roadway and install crosswalk pavement markings
Path of travel running slope is greater than 5%					
Path of travel cross slope is greater than 2% for stop control approaches	N/A	N/A		N/A	
Path of travel cross slope is greater than 5% for free-flow approaches	N/A	N/A	N/A	N/A	
Crosswalk width is less than 6'	N/A	N/A	N/A	N/A	Install crosswalk pavement markings
Crosswalk striping condition	N/A	N/A	None	N/A

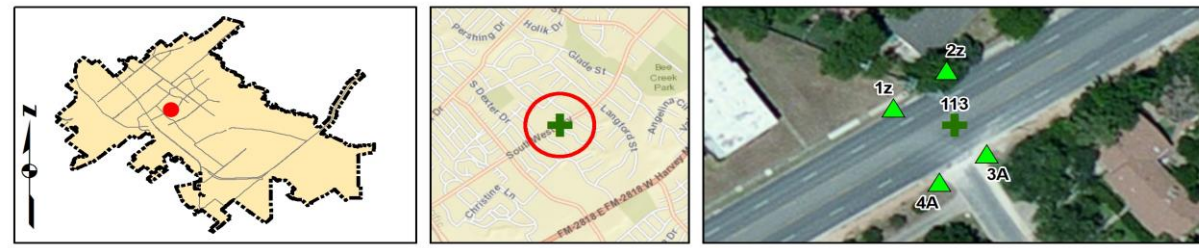
Intersection Issues	Crosswalk				Recommendations
	N	E	S	W	
Path of travel pavement condition	N/A	N/A	Dangerous	N/A	Repave roadway and install crosswalk pavement markings
Path of travel running slope is greater than 5%					
Path of travel cross slope is greater than 2% for stop control approaches	N/A	N/A	X	N/A	
Path of travel cross slope is greater than 5% for free-flow approaches	N/A	N/A	N/A	N/A	Install crosswalk pavement markings
Crosswalk width is less than 6'	N/A	N/A	N/A	N/A	
Crosswalk striping condition	N/A	N/A	None	N/A

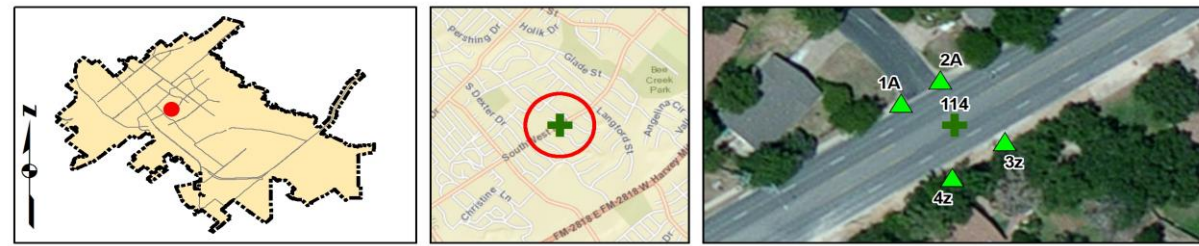
Intersection Issues	Crosswalk				Recommendations
	N	E	S	W	
Path of travel pavement condition	Dangerous	N/A	N/A	N/A	Repare roadway and install crosswalk pavement markings
Path of travel running slope is greater than 5%					
Path of travel cross slope is greater than 2% for stop control approaches	X	N/A	N/A	N/A	
Path of travel cross slope is greater than 5% for free-flow approaches	N/A	N/A	N/A	N/A	Install crosswalk pavement markings
Crosswalk width is less than 6'	N/A	N/A	N/A	N/A	
Crosswalk striping condition	None	N/A	N/A	N/A

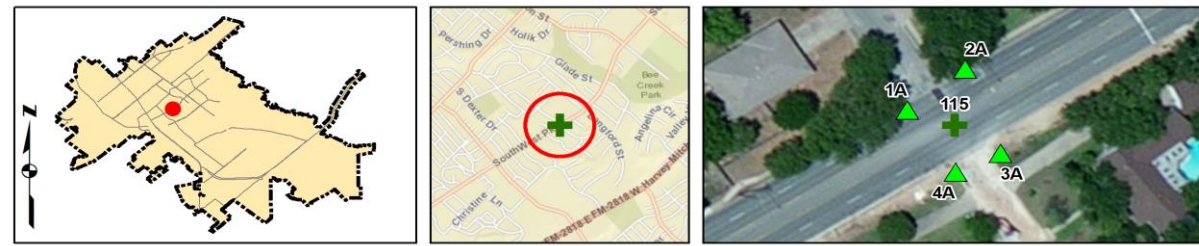
Intersection Issues	Crosswalk				Recommendations
	N	E	S	W	
Path of travel pavement condition	Dangerous	Poor	Dangerous	Poor	Repave roadway and install crosswalk pavement markings
Path of travel running slope is greater than 5%					
Path of travel cross slope is greater than 2% for stop control approaches	X	N/A	X	N/A	
Path of travel cross slope is greater than 5% for free-flow approaches	N/A	N/A	N/A	N/A	
Crosswalk width is less than 6'	N/A	N/A	N/A	N/A	Install crosswalk pavement markings
Crosswalk striping condition	None	None	None	None

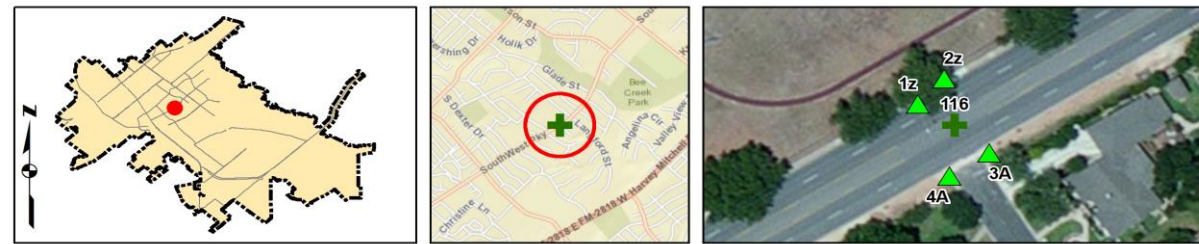
Intersection Issues	Crosswalk				Recommendations
	N	E	S	W	
Path of travel pavement condition	N/A	N/A	Dangerous	N/A	Repave roadway and install crosswalk pavement markings
Path of travel running slope is greater than 5%					
Path of travel cross slope is greater than 2% for stop control approaches	N/A	N/A		N/A	
Path of travel cross slope is greater than 5% for free-flow approaches	N/A	N/A	N/A	N/A	
Crosswalk width is less than 6'	N/A	N/A	N/A	N/A	Install crosswalk pavement markings
Crosswalk striping condition	N/A	N/A	None	N/A

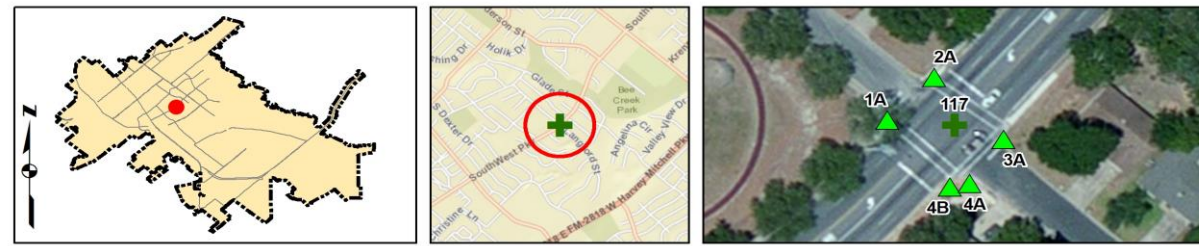
Intersection Issues	Crosswalk				Recommendations
	N	E	S	W	
Path of travel pavement condition	Poor	N/A	Good	Dangerous	Repave roadway and install crosswalk pavement markings
Path of travel running slope is greater than 5%					
Path of travel cross slope is greater than 2% for stop control approaches	X	N/A		N/A	
Path of travel cross slope is greater than 5% for free-flow approaches	N/A	N/A	N/A		Remove and replace crosswalk pavement markings
Crosswalk width is less than 6'	X	N/A			
Crosswalk striping condition	Worn	N/A	Good	Worn

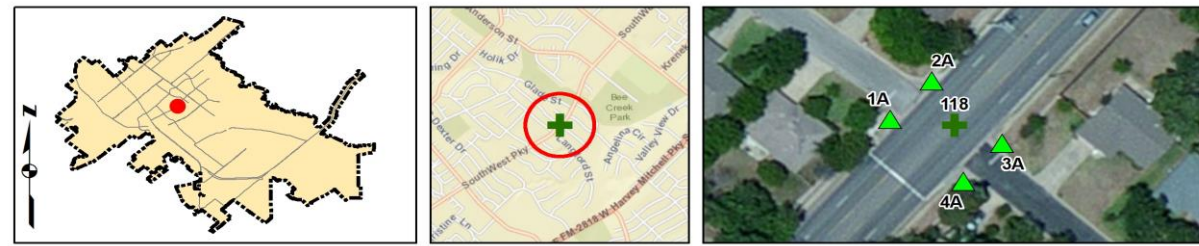
Intersection Issues	Crosswalk				Recommendations
	N	E	S	W	
Path of travel pavement condition	Poor	N/A	Poor	N/A	Repare roadway and install crosswalk pavement markings
Path of travel running slope is greater than 5%					
Path of travel cross slope is greater than 2% for stop control approaches	X	N/A	X	N/A	
Path of travel cross slope is greater than 5% for free-flow approaches	N/A	N/A	N/A	N/A	
Crosswalk width is less than 6'		N/A		N/A	
Crosswalk striping condition	Good	N/A	Good	N/A

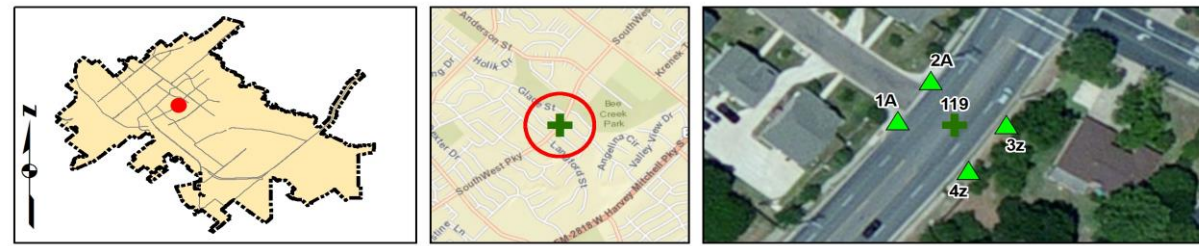
Intersection Issues	Crosswalk				Recommendations
	N	E	S	W	
Path of travel pavement condition	Poor	N/A	N/A	N/A	Repave roadway and install crosswalk pavement markings
Path of travel running slope is greater than 5%					
Path of travel cross slope is greater than 2% for stop control approaches	X	N/A	N/A	N/A	
Path of travel cross slope is greater than 5% for free-flow approaches	N/A	N/A	N/A	N/A	
Crosswalk width is less than 6'	N/A	N/A	N/A	N/A	Install crosswalk pavement markings
Crosswalk striping condition	None	N/A	N/A	N/A

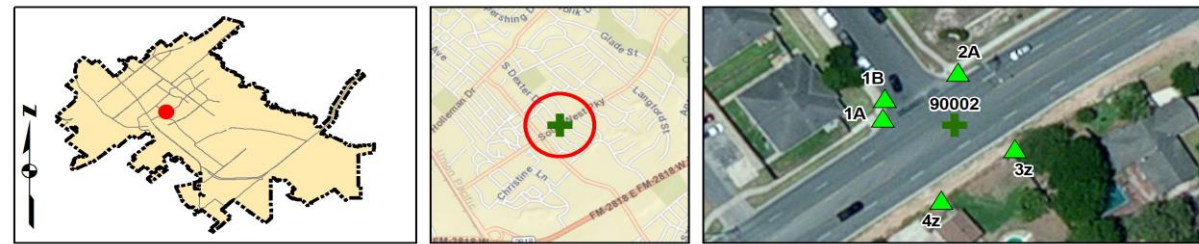
Intersection Issues	Crosswalk				Recommendations
	N	E	S	W	
Path of travel pavement condition	Poor	Good	N/A	Good	Repave roadway and install crosswalk pavement markings
Path of travel running slope is greater than 5%					
Path of travel cross slope is greater than 2% for stop control approaches		N/A	N/A	N/A	
Path of travel cross slope is greater than 5% for free-flow approaches	N/A	N/A	N/A	N/A	
Crosswalk width is less than 6'	N/A	N/A	N/A	N/A	Install crosswalk pavement markings
Crosswalk striping condition	None	None	N/A	None
